# THE ARUP JOURNAL

Vol. 5 No. 3 September 1970  
Published by  
Ove Arup & Partners Consulting Engineers  
Arup Associates Architects and Engineers  
13 Fitzroy Street, London, W1P 6BQ

An engineer looks at architecture, by Ove Arup	2
Prestressed concrete congress, Prague, June 1970, by D. Dowrick	4
The Carlton Centre, by R. Heydenrych	5
The use of prestressing foundation strengthening at York Minster, by D. Dowrick	6
St. Katharine Docks, by M. Tucker	10
The changing face of concrete, by T. O'Brien	20
Beecham Research Laboratories: an exercise in simplicity, by A. Hart	24

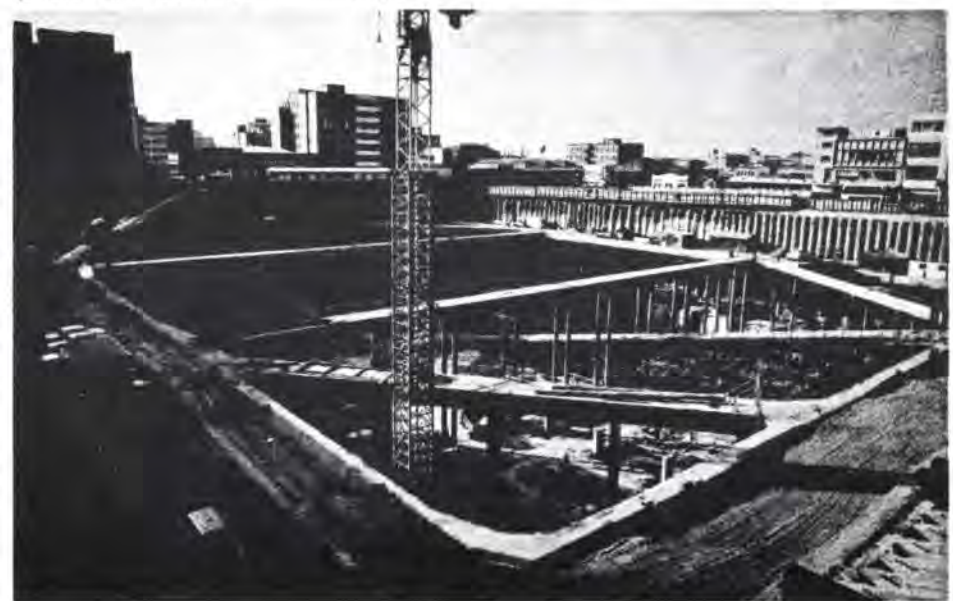
Fig. 1

The excavation for the Carlton Centre basement  
(Photo: A. A. Gordon, Johannesburg)

In order to control the deterioration of the earth face and to allow for a simple propping procedure, 1.1 m (3 ft. 6 in.) diameter cast-in situ piles were installed at approximately 2.3 m (7 ft. 6 in.) centres along the perimeter of the site. These piles were, in general, carried down below the lowest basement level. Later in the contract, gunite arches were formed between the piles to complete a continuous permanent retaining wall.

The bracing structure took the form of a temporary rectangular prestressed concrete grid. While the principal structural behaviour of the grid was as a compression ring it was necessary to ensure full stability with unbalanced loading conditions and, for this reason, the additional struts across the site were added.

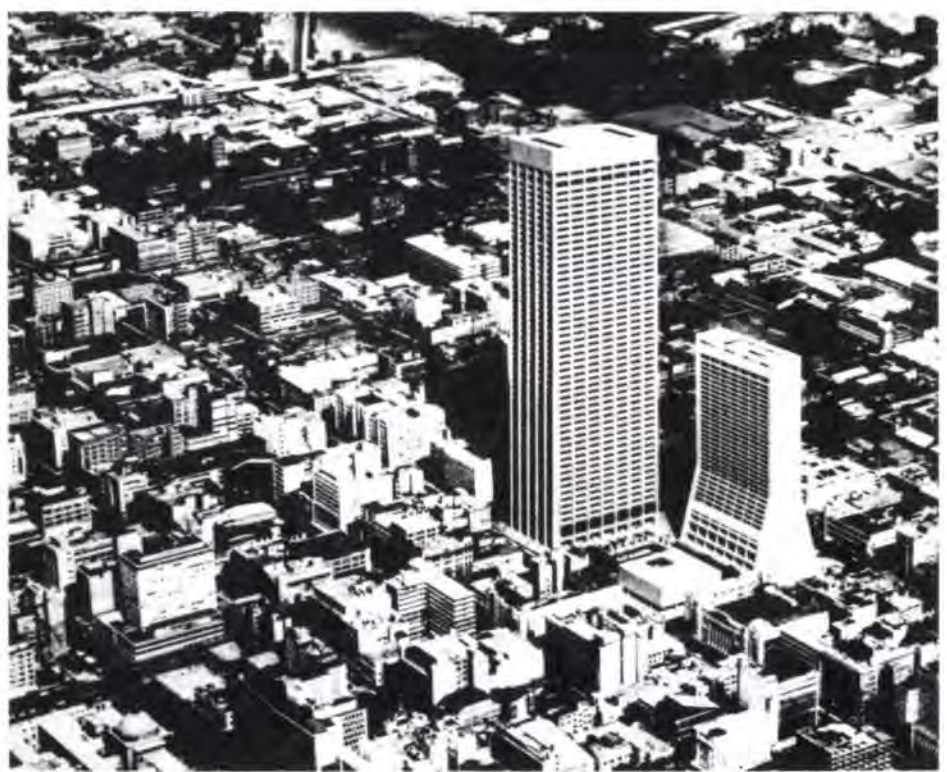
**Fig. 2**  
Artist's impression of the completed Carlton Centre

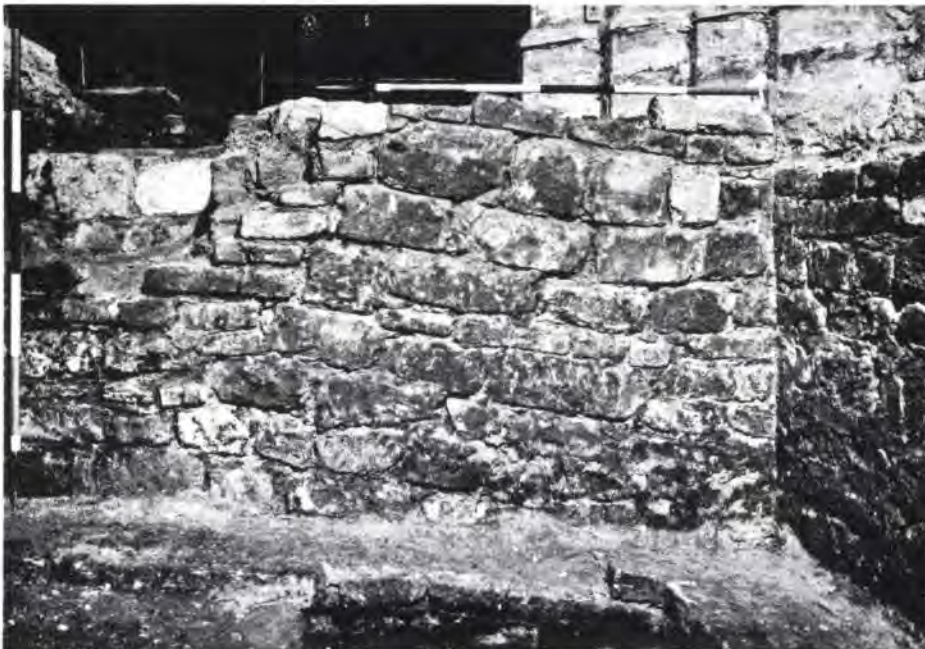
**Fig. 5**  
Distortions in Norman walls below present floor level due to column on the right (Photo: by courtesy of the Royal Commission on Historic Monuments)

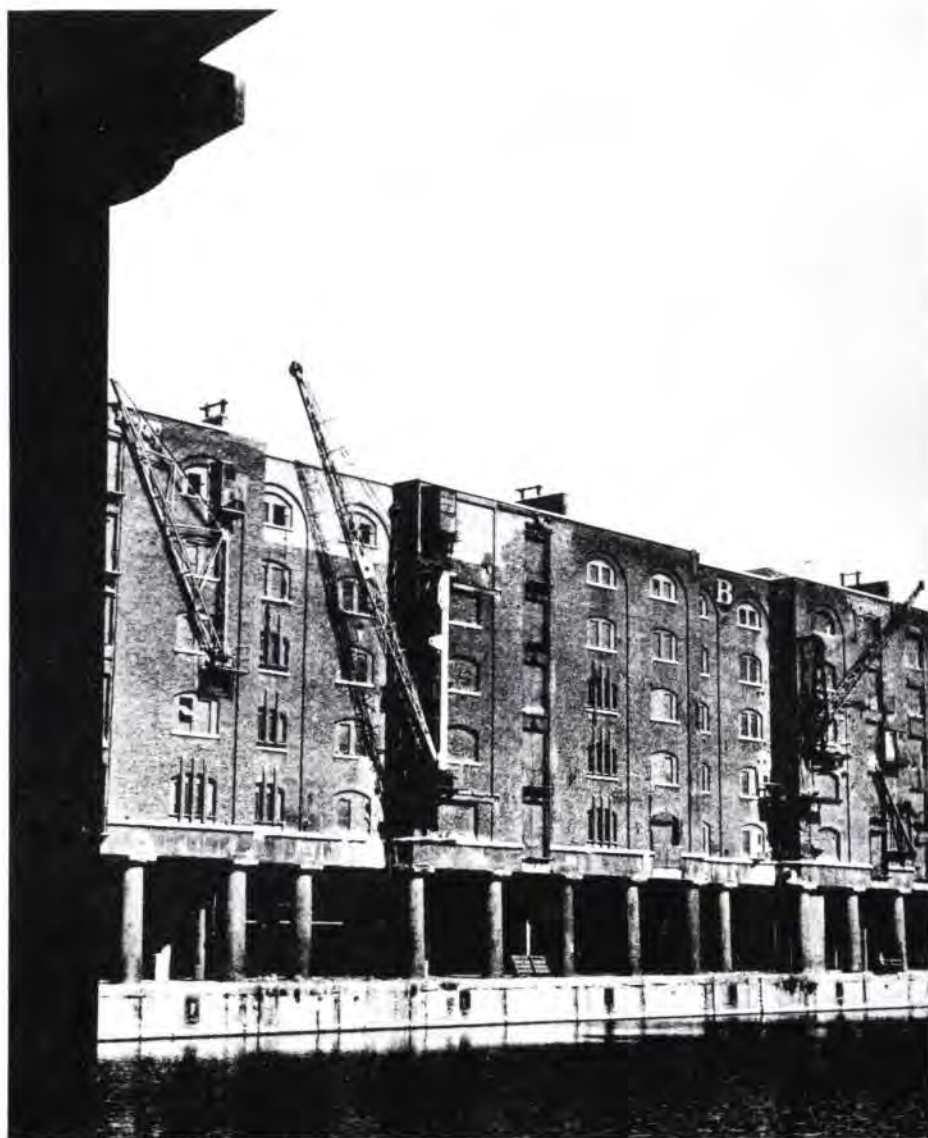
**Fig. 4**  
B warehouse dock facade  
(Photo: Malcolm Tucker)

Around the docks on three sides, six multi-storey warehouse blocks (stacks) were planned. These were built hard up against the water's edge, being supported above the quay on giant columns. This was a novel idea, partly to save space and partly to enable goods to be hoisted directly from the holds of ships into the warehouses. In the earlier docks, the warehouses had been set back behind a wide quay where cargoes were unloaded and sorted before dispatch to the warehouses. The new system eliminated double handling, with a corresponding reduction in spillages and pilfering. Cargoes could also be unloaded on to the quays, which extended beneath the warehouses, but these were somewhat congested by the supports for the structure above. Unfortunately, a ship's cargo would frequently be destined for more than one warehouse, in which case it was necessary for the ship to move its berth several times, which reduced the efficiency of the system. The principle was adopted by Jesse Hartley for his impressive docks in Liverpool (e.g. Albert Dock 1843, Stanley Dock 1857), but it was not used for the later docks in London.

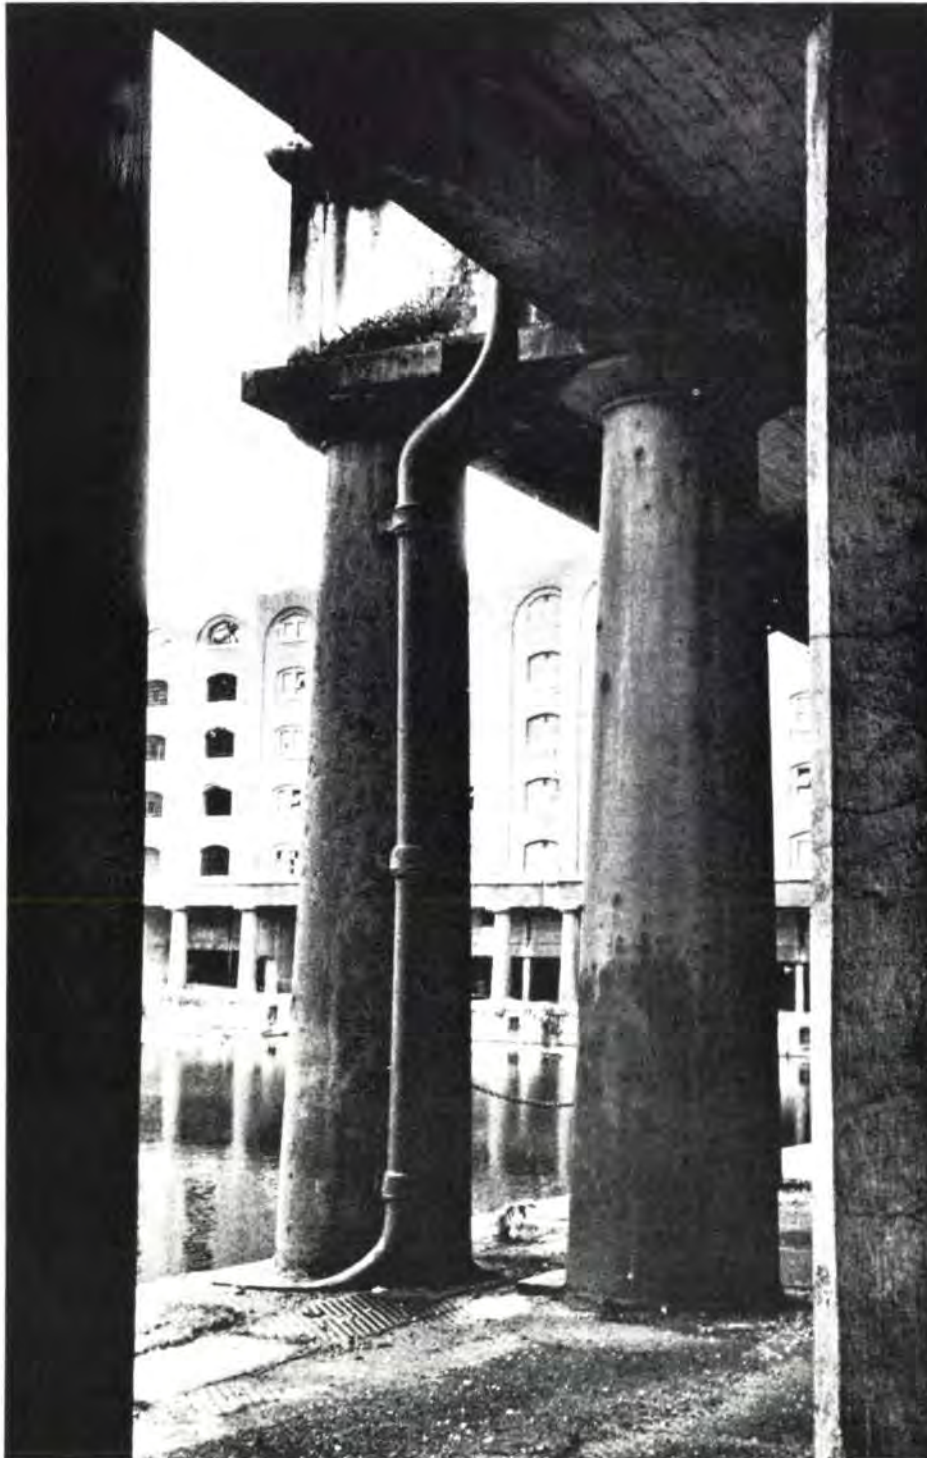
**Fig. 5**  
Doric columns on the quay beneath B warehouse.  
Note rainwater drain pipe (Photo: Malcolm Tucker)

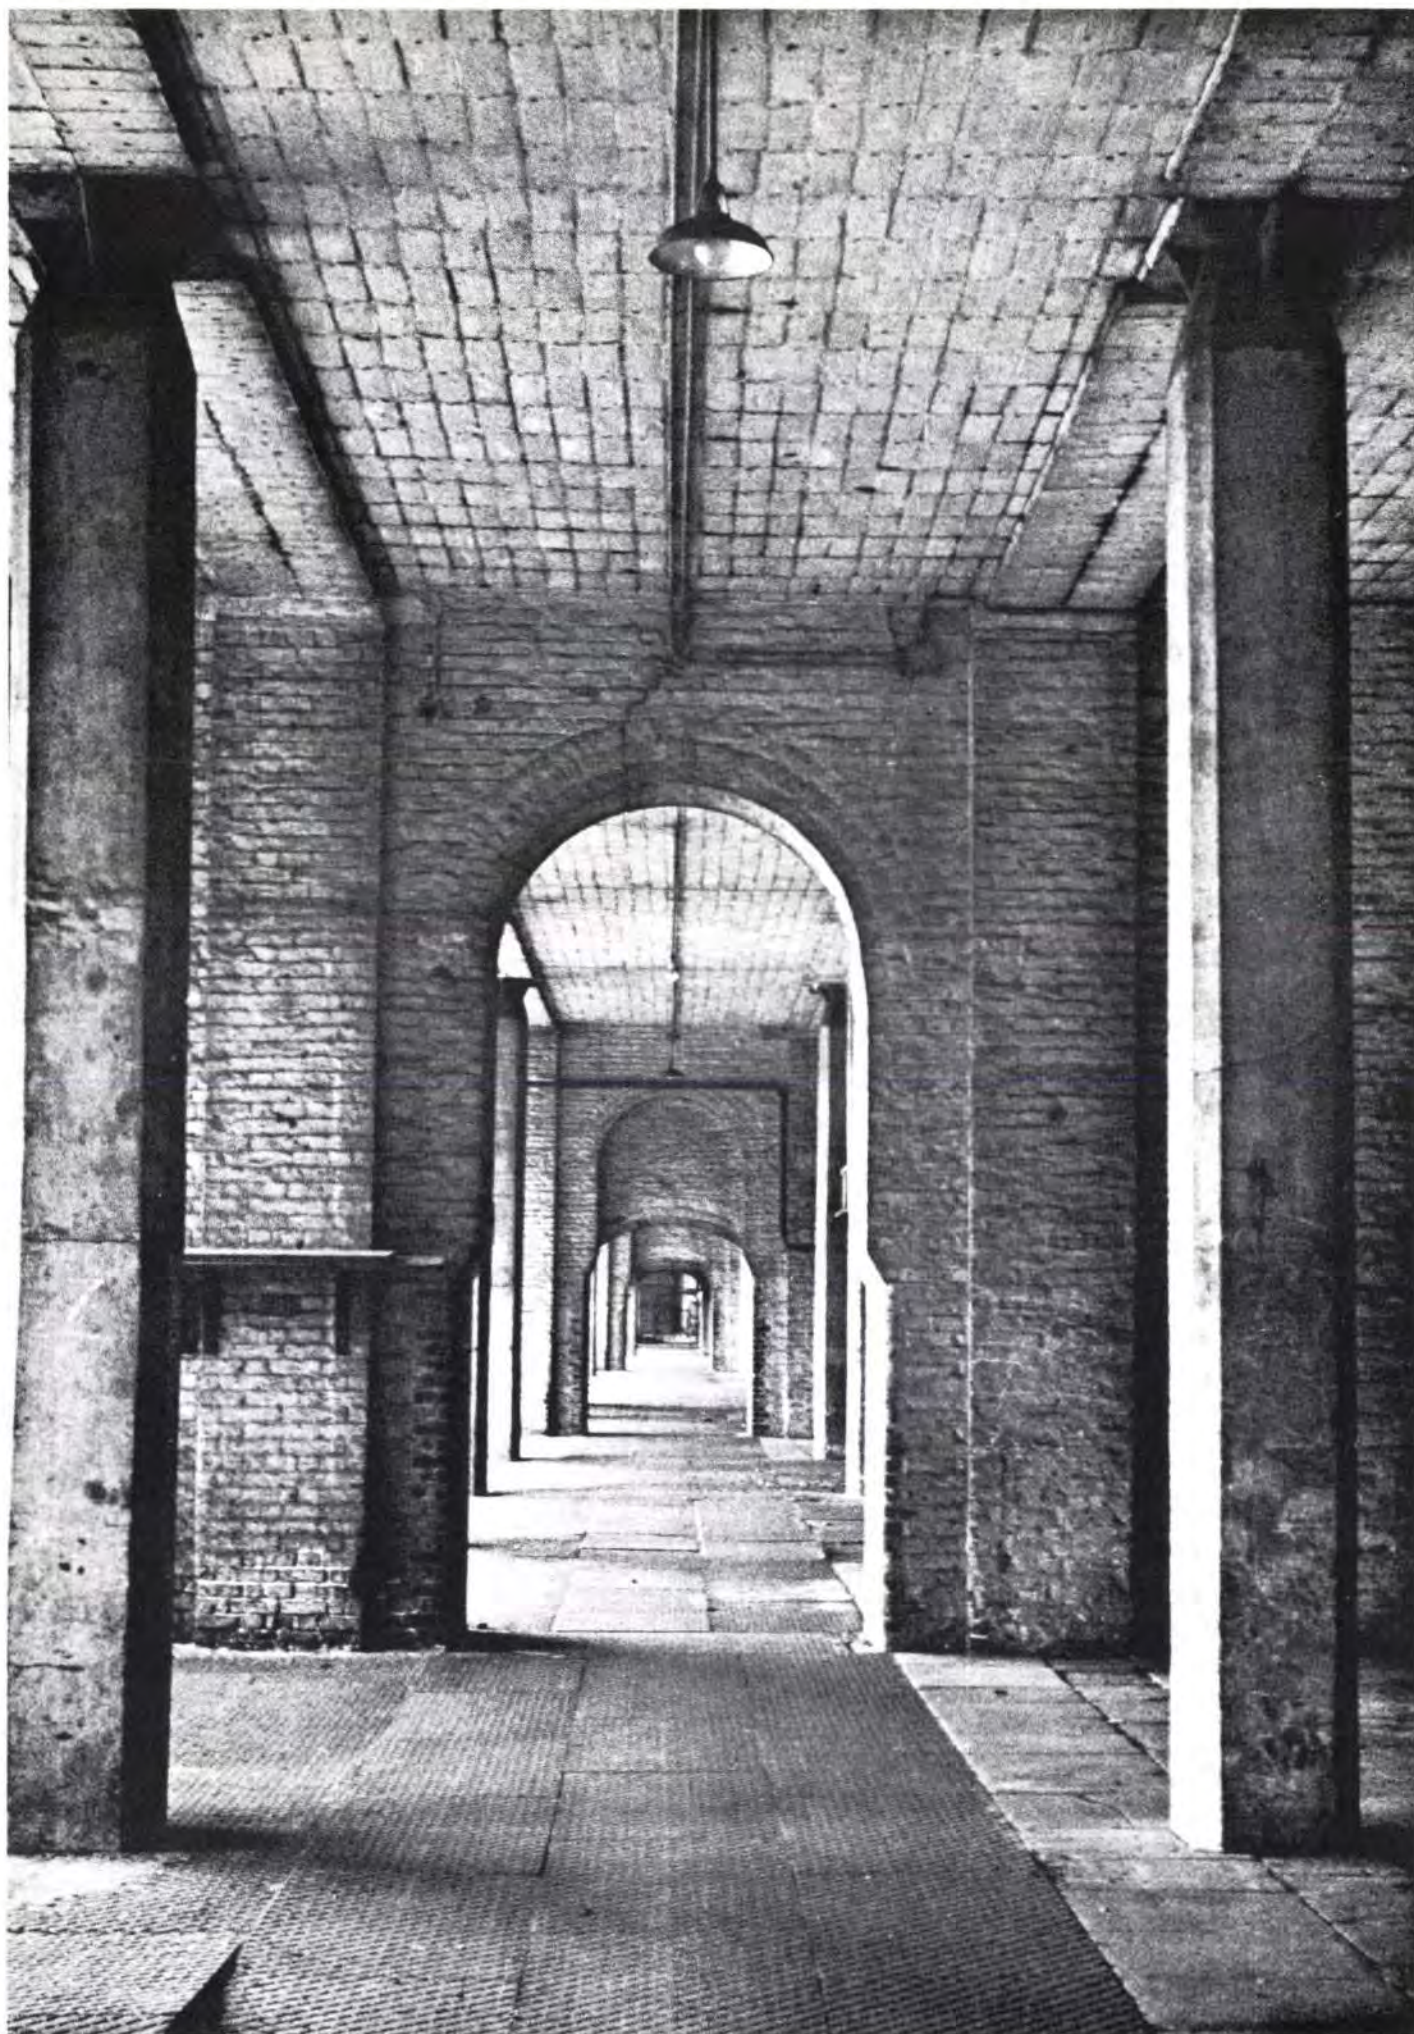
**Fig. 6**  
View along the quay beneath B warehouse, interrupted at intervals by fire walls  
(Photo: Malcolm Tucker)

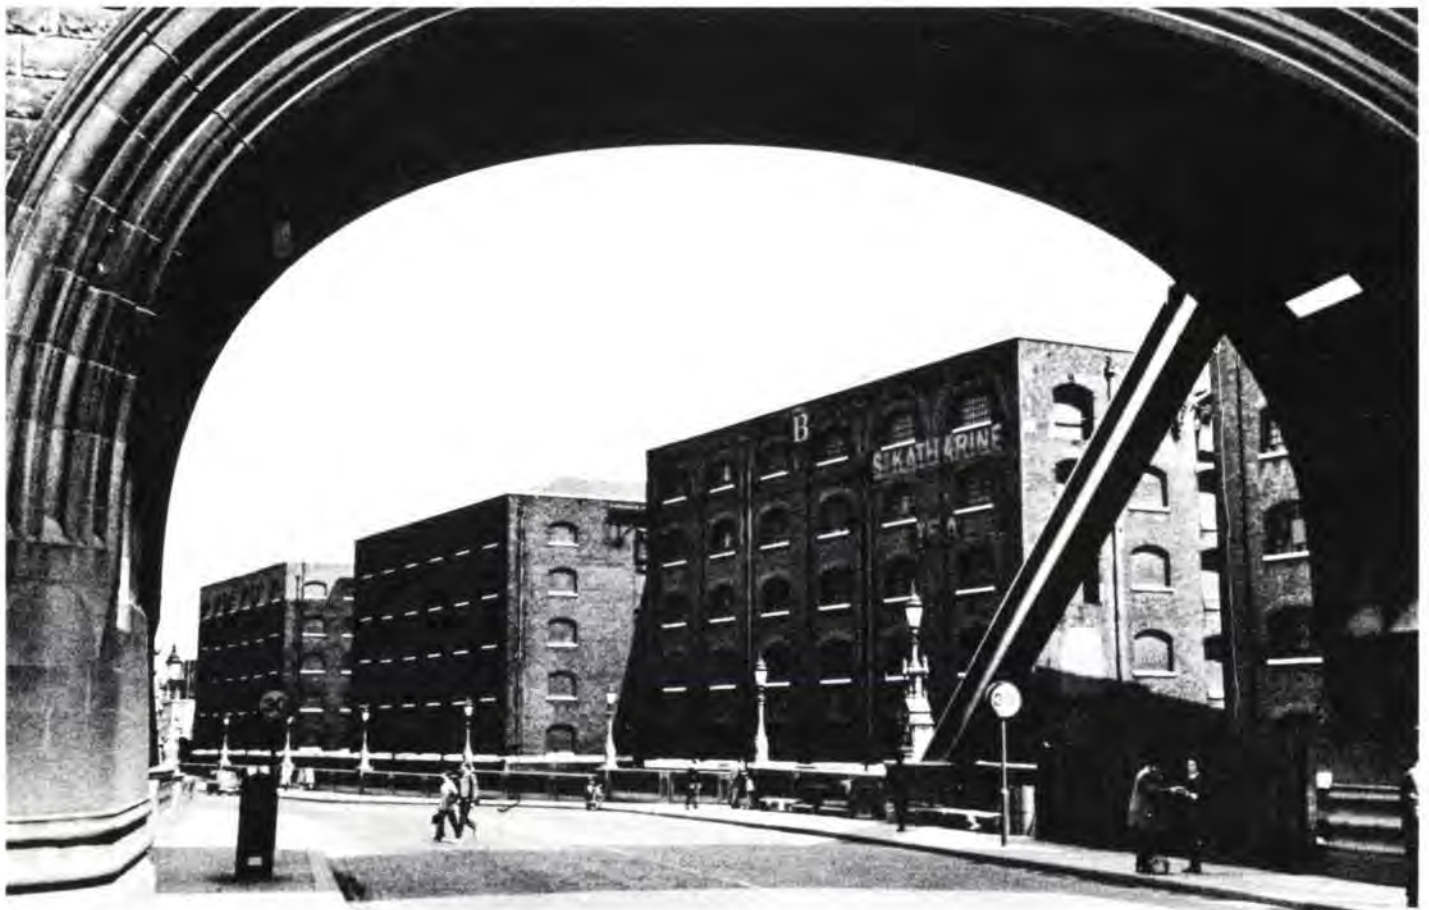
**Fig. 7 above**  
General view of B warehouse (1828)  
from Tower Bridge  
(Photo : Malcolm Tucker)

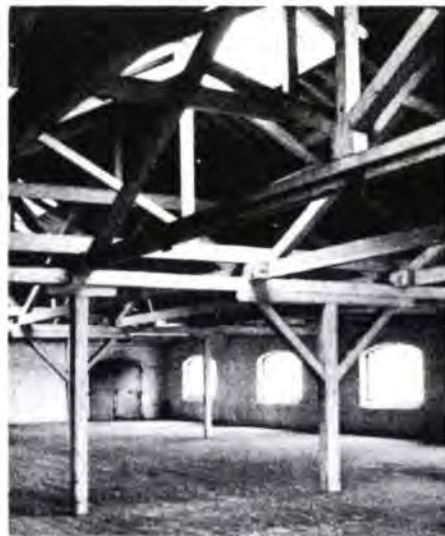
**Fig. 8 left**  
Intersecting king post trusses  
in the roof of B warehouse  
(Photo : Malcolm Tucker)

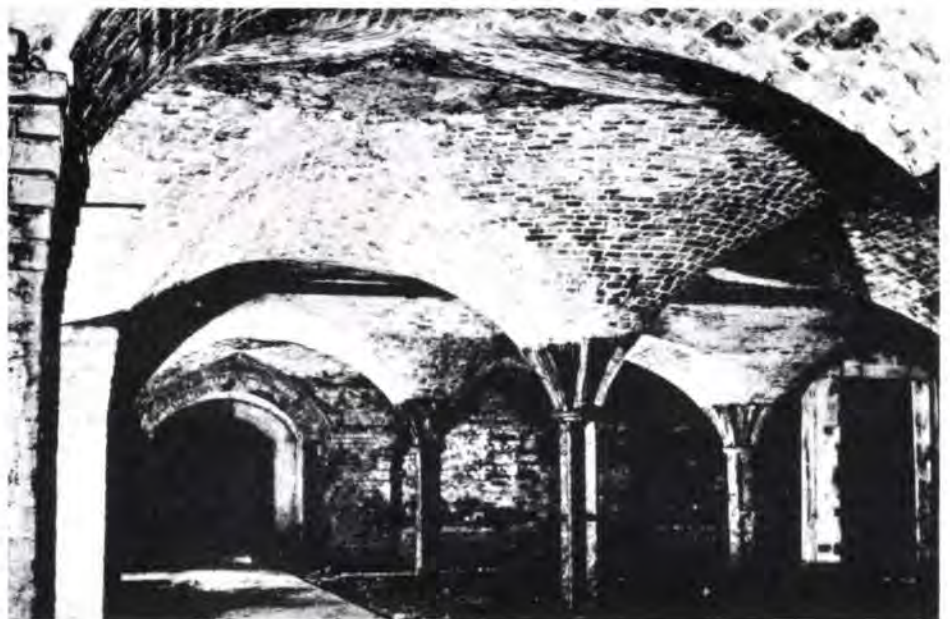
**Fig. 9 below**  
Groined vaults on cast iron  
columns under C warehouse (1828)  
(Photo : J. Flowerday)

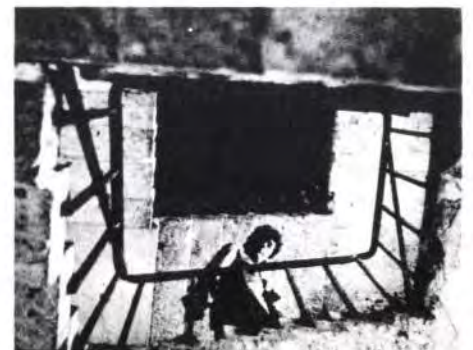
#### Fig. 12 below

Massive sandstone stair treads in I warehouse (Photo: Malcolm Tucker)

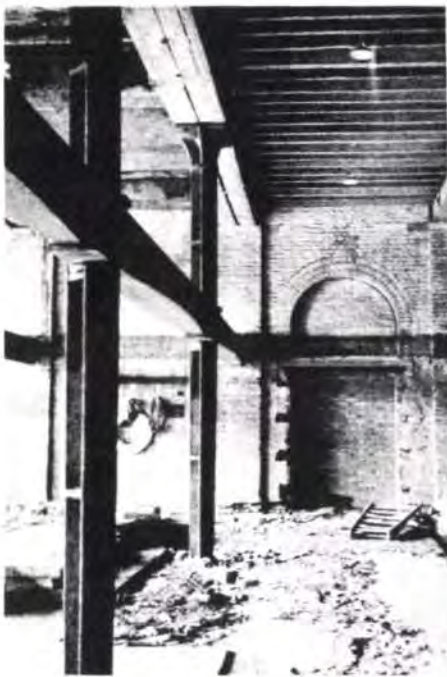
**Fig. 13 above**  
Fishbelly flanged beams for a mezzanine floor of 1855, inserted between the original cruciform columns of C warehouse  
(Photo: Malcolm Tucker)

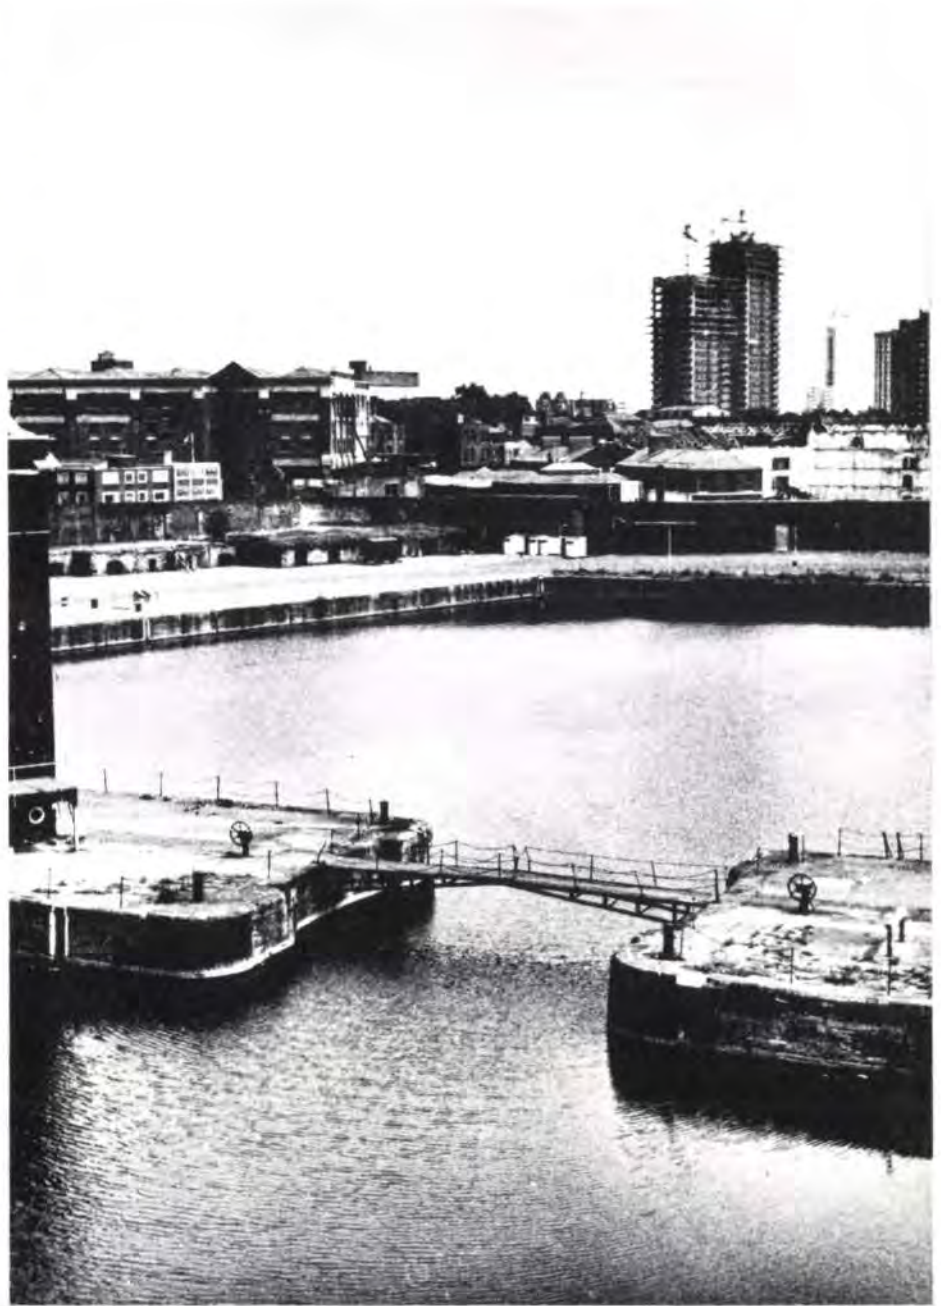
**Fig. 15 right**  
Cast iron retracting footbridge of 1828 at entrance to the Eastern Dock  
(Photo: Malcolm Tucker)

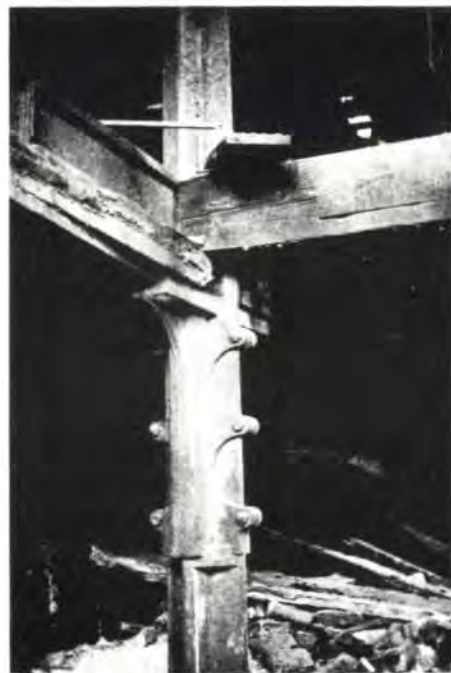
**Fig. 14 below**  
Cast iron clamp (c.1855) to support the later mezzanine floor  
(Photo: Malcolm Tucker)

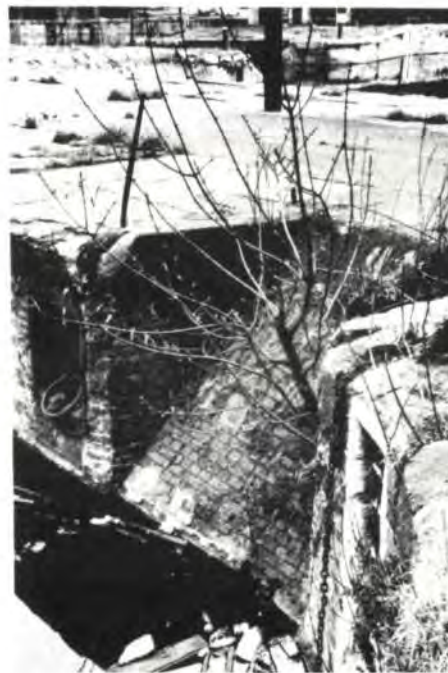
**Fig. 16 below**  
Recess in quay for the bowsprit of a sailing ship. Note mooring rig  
(Photo: Malcolm Tucker)

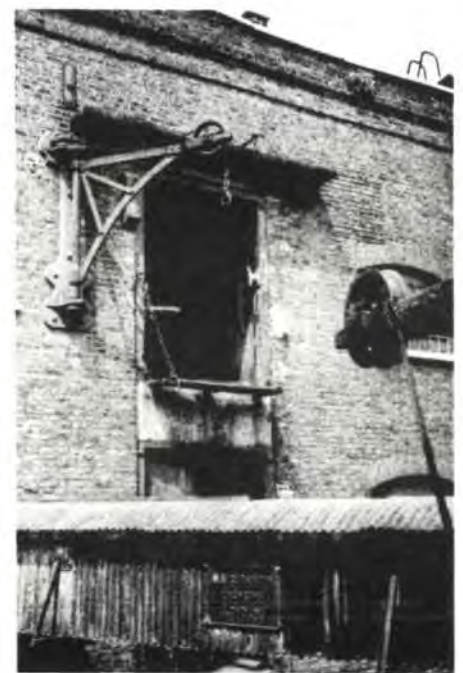
**Fig. 17 below**  
A jigger rib on H warehouse  
(Photo: Malcolm Tucker)

Wrought iron jibs of 430 Kg (8½ cwt.) SWL projected from the walls of the topmost floors to hoist goods up the sides of the warehouses. These and various other devices in the original scheme were supplied by Joseph Bramah. The hand winches or 'jiggers' used for hoisting were partly counterbalanced by a weight descending through the building. Goods being lowered were controlled by a band brake on the winch, operated via a foot treadle by a 'jiggerman' who leant out precariously through the loophole on a curved bracket at waist level.

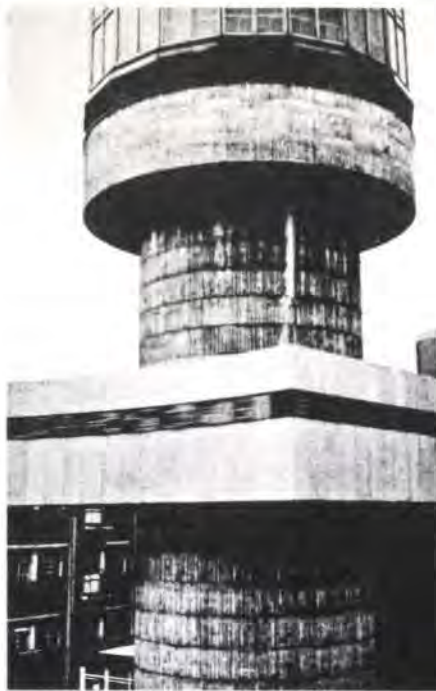
1

**Fig. 1**  
Uniformity of weathering is achieved through uniform exposure and uniform absorbency of surface. The in situ board-marked concrete is contrasted with the precast exposed aggregate panels. The light streak is due to the cleansing effect of a water discharge. The colour of the wider cylinder has changed from grey to yellow-brown as the cement has been leached away exposing the sand. (About seven years)

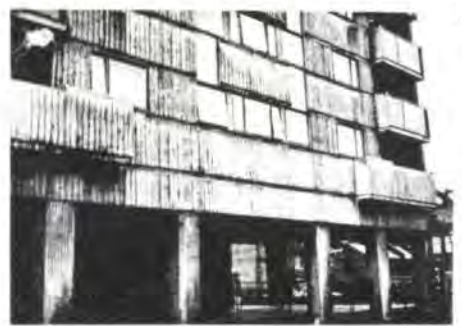
2

**Fig. 2**  
White in situ board-marked concrete fares no better in city atmospheres. (About eight years)

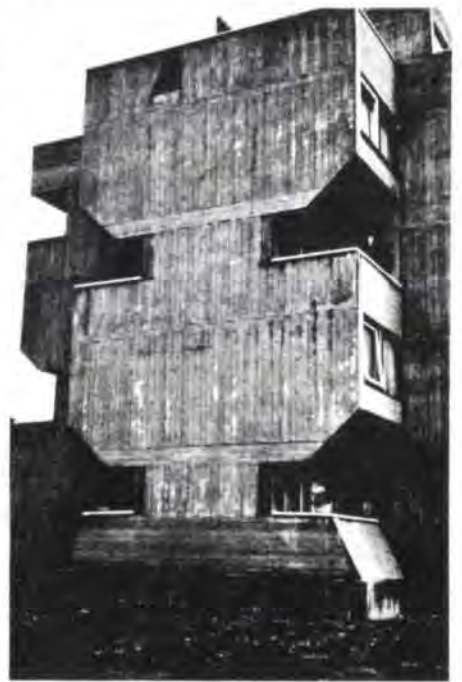
4

**Fig. 4**  
One technique for overcoming this problem is to paint the in situ concrete with concrete coloured paint. Of course, this looks unsightly when it begins to break down. Note the mould growth on the plinth where the detailing provides a water trap. (About four years)

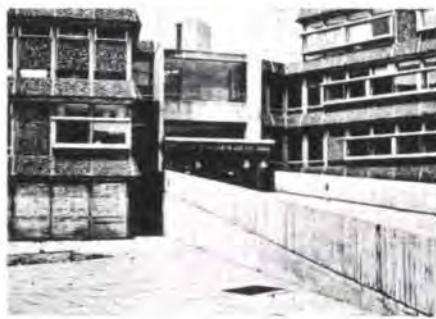
3

**Fig. 3**  
This is another example of the superior weathering of precast exposed aggregate panels. (About three years)

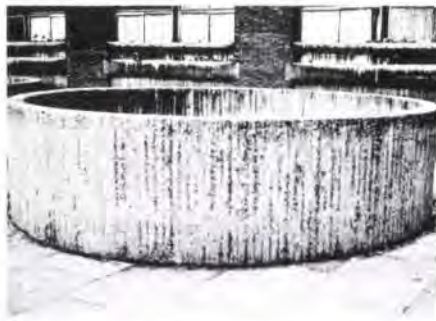
5

**Fig. 5**  
With older concrete the quality may be such that the erosion of the surface through acidic rainwater attack may outpace dirt deposition. The surface is self cleansing, but the appearance is still not satisfactory. (About eight years)

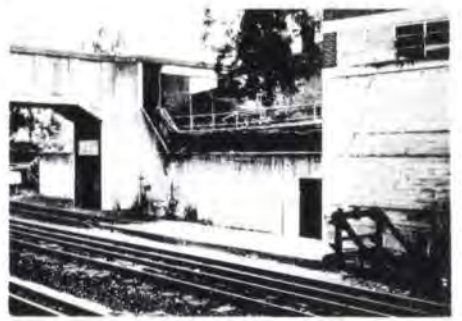
6

**Fig. 6**  
The black and white photograph does not adequately show that the retaining wall and bridge have turned green with mould, whilst the wall of the building has turned brown due to exposure of the sand. The difference is attributable to the moisture content difference between walls of heated and unheated spaces. (About forty years)

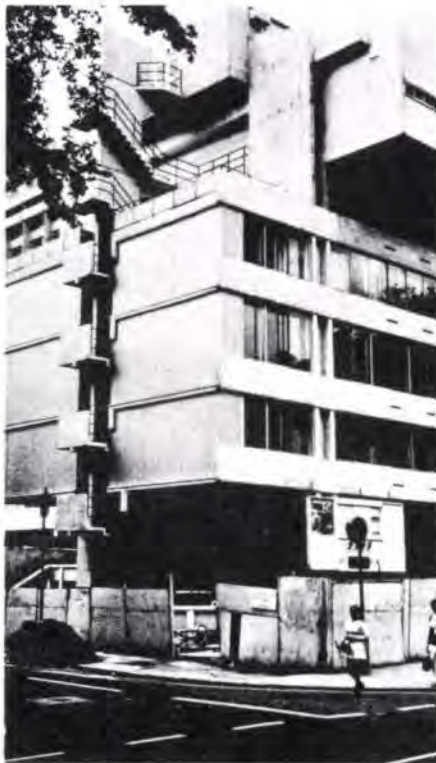
7

**Fig. 7**  
Smooth white permeable concrete weathers so badly in cities, that the appearance may be disfigured before the building is finished. (New)

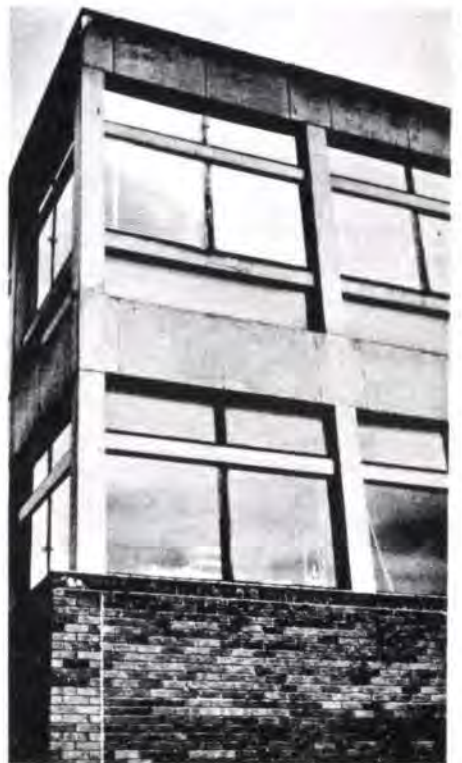
8

**Fig. 8**  
It is nearly impossible to patch concrete in such a way that the patch weathers uniformly with the rest of the concrete. The roof edge concrete is turning green with mould. Note also the tell-tale signs of reinforcement corrosion on one transom. (About seven years)

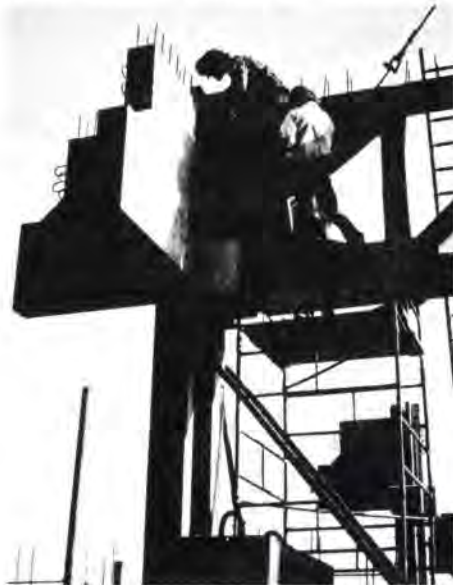
**Fig. 5**  
Connection detail between corner column and precast truss. Side shutters for in situ concrete stitch being fixed  
(Photo: Beecham Research Laboratories)

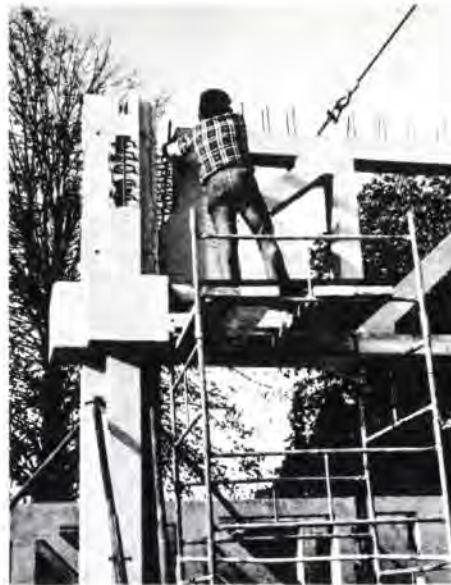
**Fig. 6**  
Typical connection detail prior to concreting of truss to cruciform section column  
(Photo: Beecham Research Laboratories)

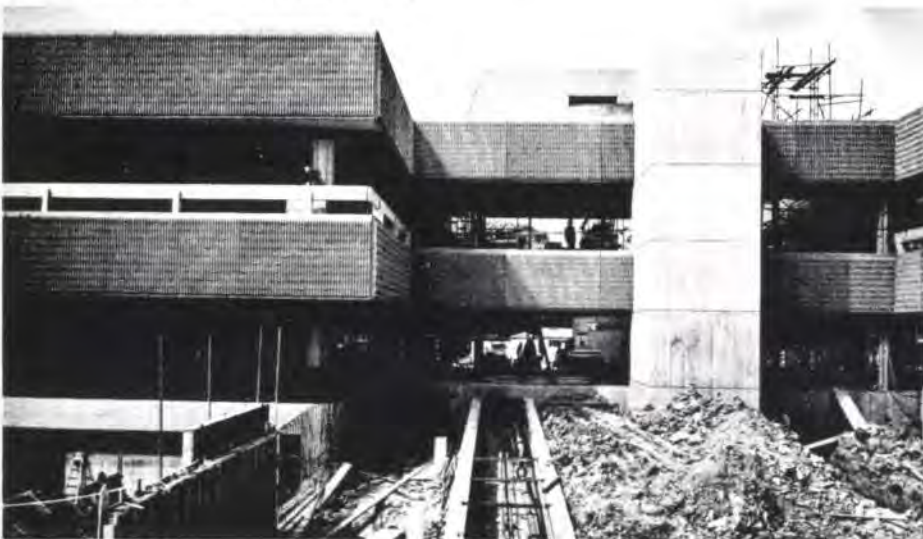
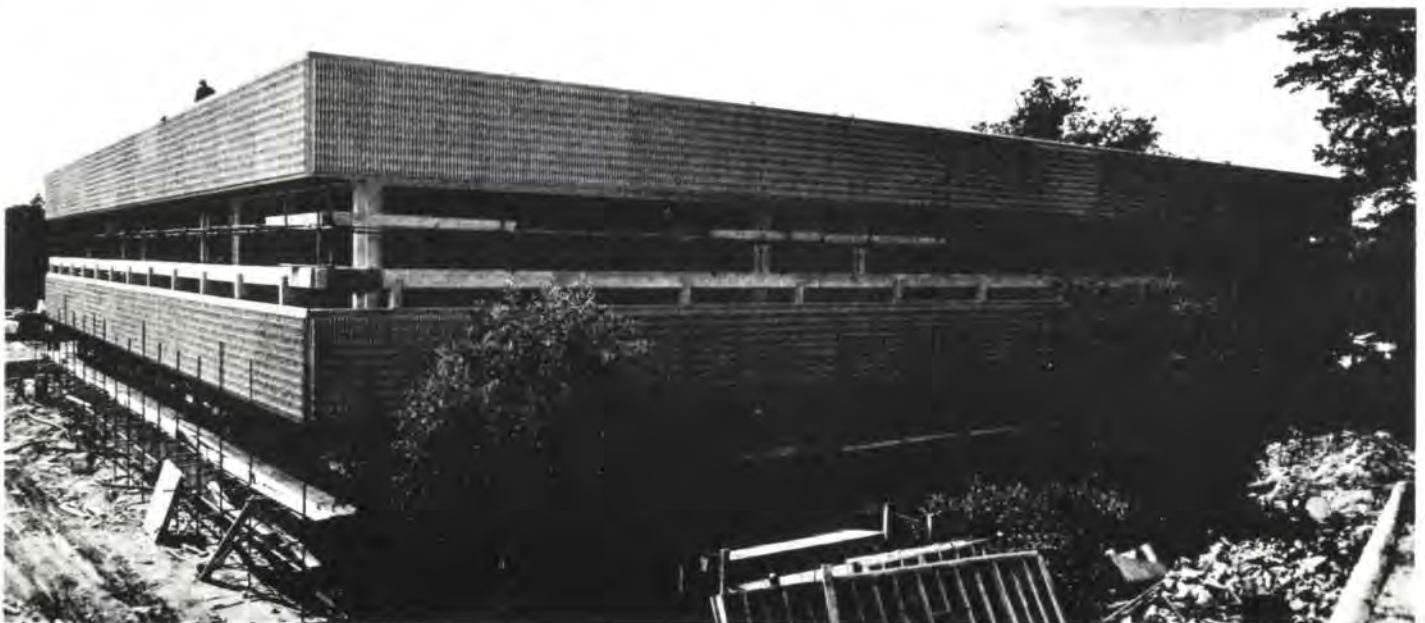
**Fig. 8**  
In situ concrete link block between North & South Blocks  
Fascia panels are precast as for the main blocks  
(Photo: Beecham Research Laboratories)

**Fig. 9**  
North Block on completion of the structural frame (Photo: Beecham Research Laboratories)
