THE ARUP JOURNAL

OCTOBER 1973

Sydney Opera House

Ove Arup
and Jack Zunz

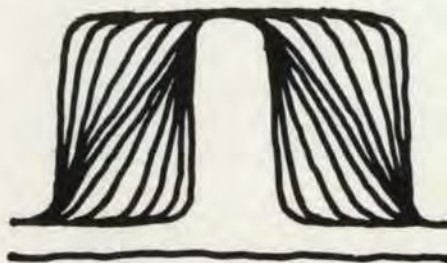
Fig. 5 Proposed round-edged sections

It appeared that there were not so many simple ways of effecting this transition, if one observed the rule that the cross-sections should always be made up of straight lines, which would then produce twisted surfaces which could be made up of plywood. The method proposed in Fig. 3 (c) and (d) seemed to be the simplest possible, i.e. tilting the side B-C (Fig. 12, p.7), rotating it round point B until point C coincided with D,

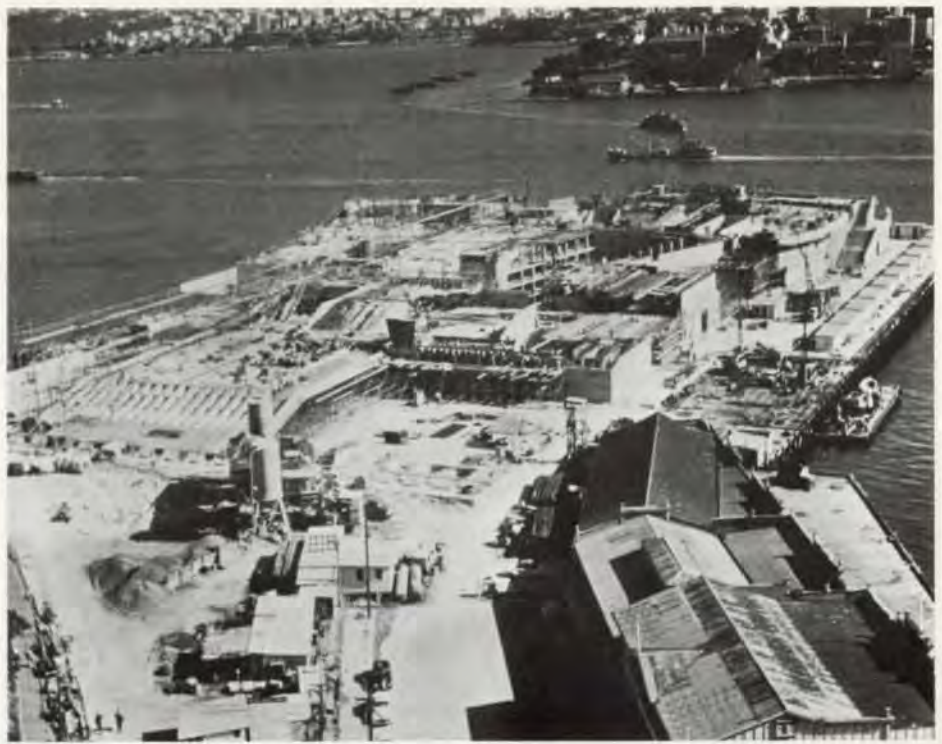
Fig. 12
Construction sequence

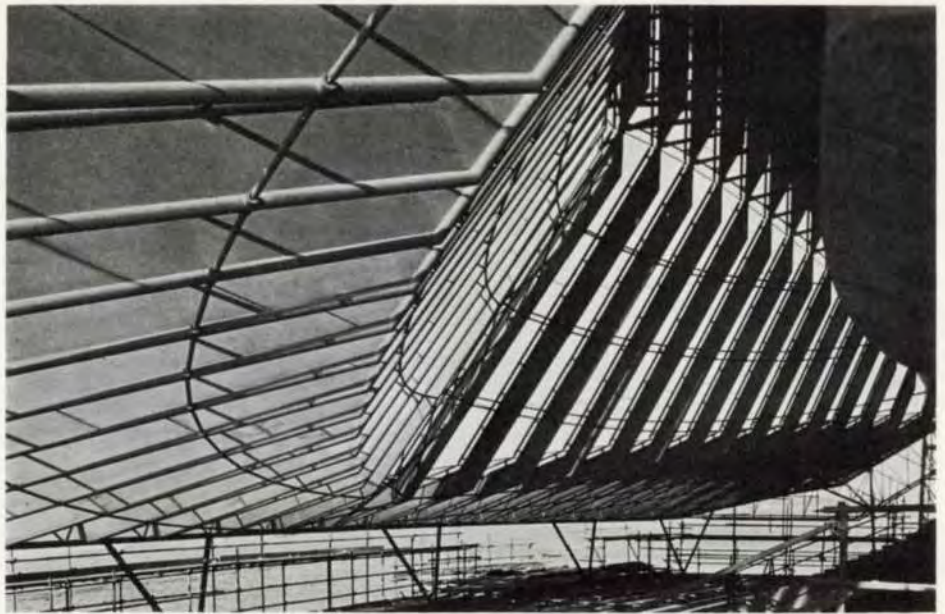
Fig. 10
Glass wall A4: structure (Photo: Harry Sowden)

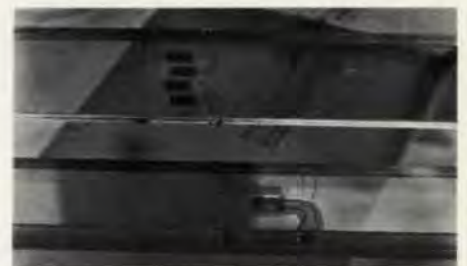
Fig. 15
Laminated glass test beams with strain gauges attached
(Photo: Harry Sowden)

During the tests, in which the beams were loaded in four-point bending, measurements were taken of surface strain and central deflection; detailed test results, together with an analytical solution to the problem, are given elsewhere.³ To summarize, however, the degree of coupling between the two glass layers was found to be chiefly dependent upon the shear modulus of the plastic interlayer. The measured load/deflection curves were sensibly linear, but for beams with a soft interlayer, the bending stiffness was very much lower than that for a monolithic glass beam of the same overall thickness. The effect of this reduction in stiffness on bending stresses is typified by the results given in Fig. 16 for a beam with nominal 10 mm and 6 mm glass layers and a 0.76 mm thick plastic interlayer; here, the maximum tensile stress in the beam with a soft interlayer is 70 per cent greater than the corresponding stress in a similar beam containing a hard interlayer, and 80 per cent greater than the maximum bending stress in a monolithic glass beam of the same overall thickness.

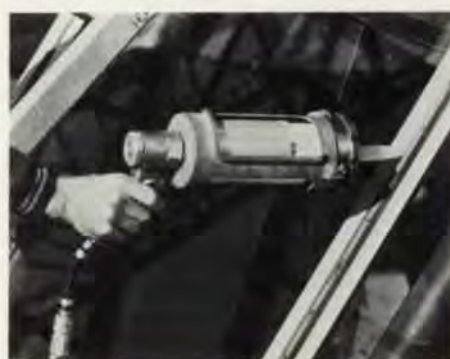
Fig. 27
Application of silicone rubber seal
(Photo: Harry Sowden)

The choice of silicone rubber was really dictated by the presence of the horizontal glass-to-glass butt joints. These joints are directly exposed to the atmosphere and silicone rubber, besides having an excellent adhesion to glass, has a high resistance to ultra-violet radiation and other weathering agencies. Furthermore, its elastic properties ensure that it remains
