# THE ARUP JOURNAL

Vol. 9 No. 4 December 1974  
Published by  
Ove Arup Partnership  
13 Fitzroy Street, London, W1P 6BQ

# The North Seaton Bridge

# Gateshead Western Bypass

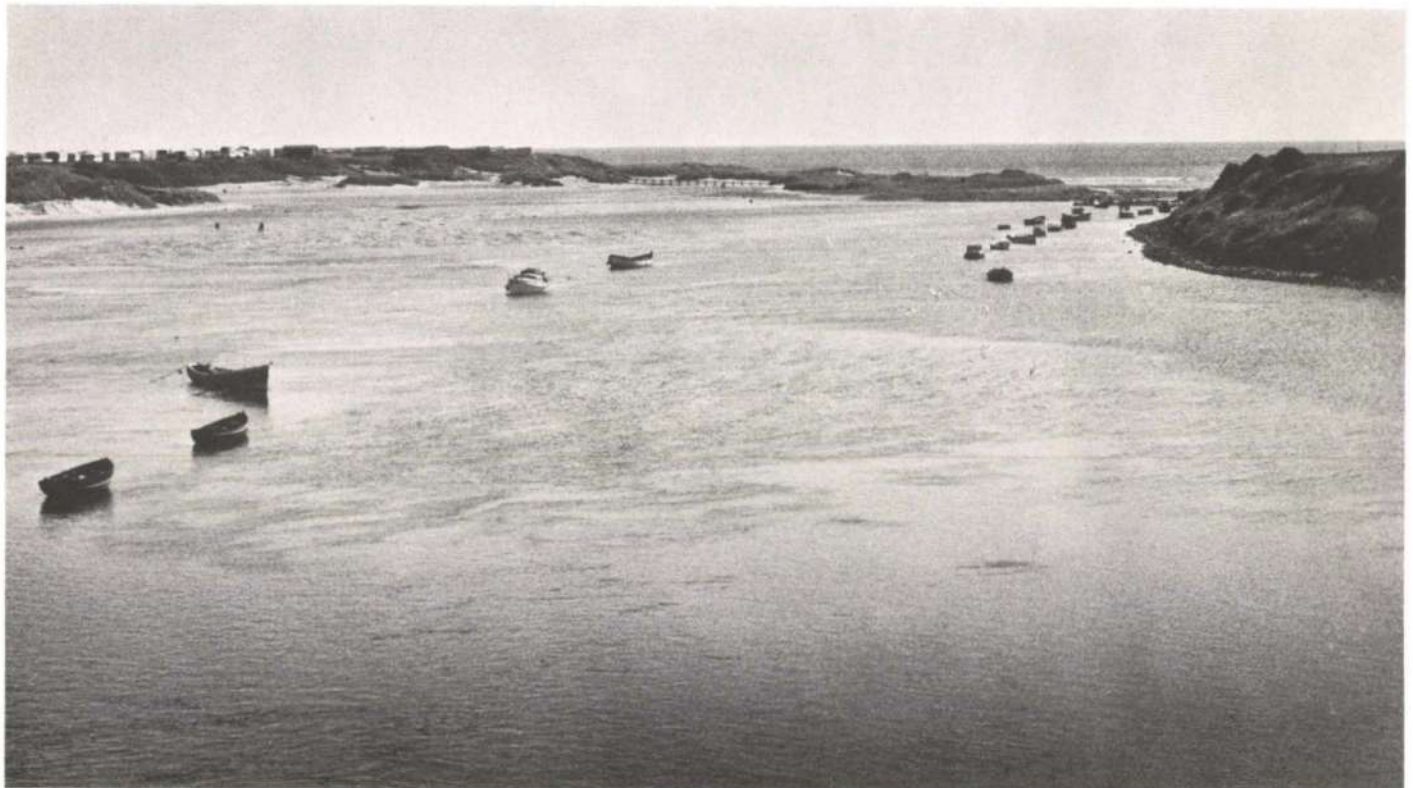
## Fig. 2

The estuary from the bridge, with the sea beyond. (Photo: Bill Smyth)

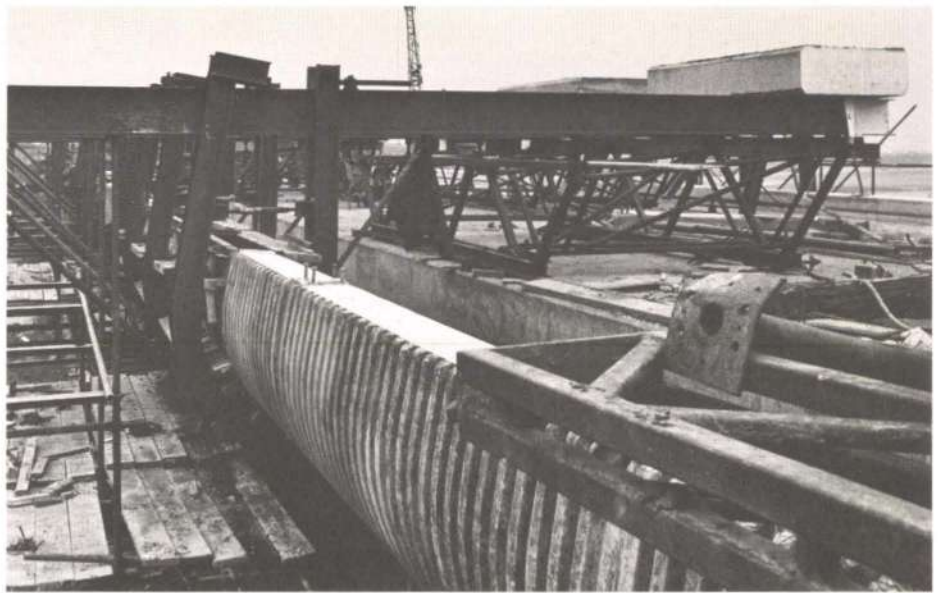
**Fig. 15**  
Ribbed edge & steel frames for edge forms.  
(Photo: Harry Sowden)

special to them. The edge of the bridge, where the streaking is most likely to be a problem, is cast on afterwards and gives a lot of re-use of formwork so we felt able to put vertical grooves in it.

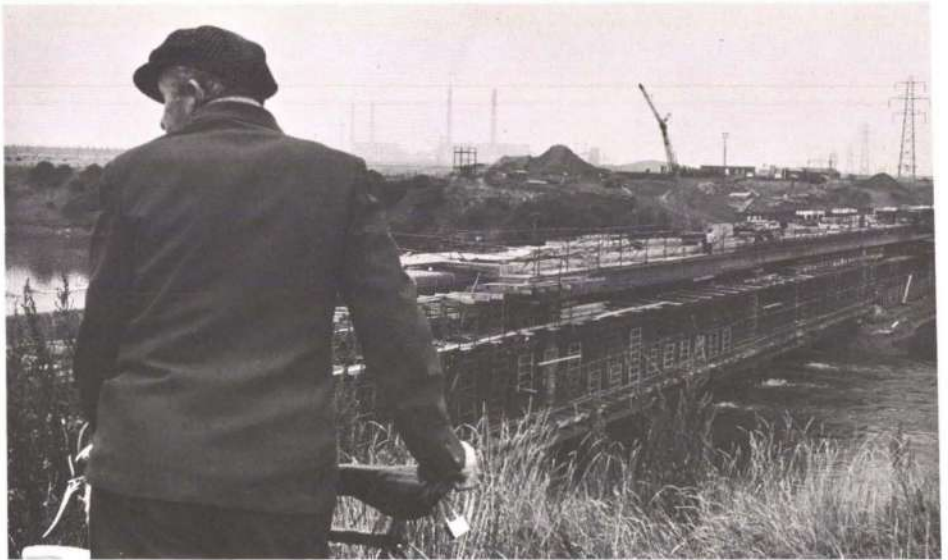
**Fig. 19**

The temporary jetty with the bund to the left. (Photo: Harry Sowden)

The first problem in building the bridge was the access. The contractor originally hoped to build a bund of shale halfway across the valley to construct three spans of the bridge, then to remove the bund and to build another one across the other half of the valley to construct the other three spans. This was not allowed by

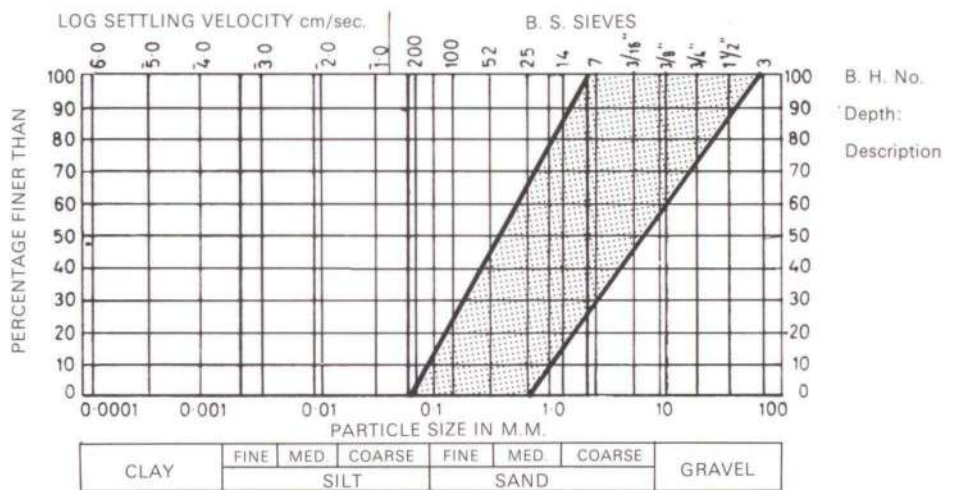
**Fig. 7**  
Limits of grading for drain aggregates

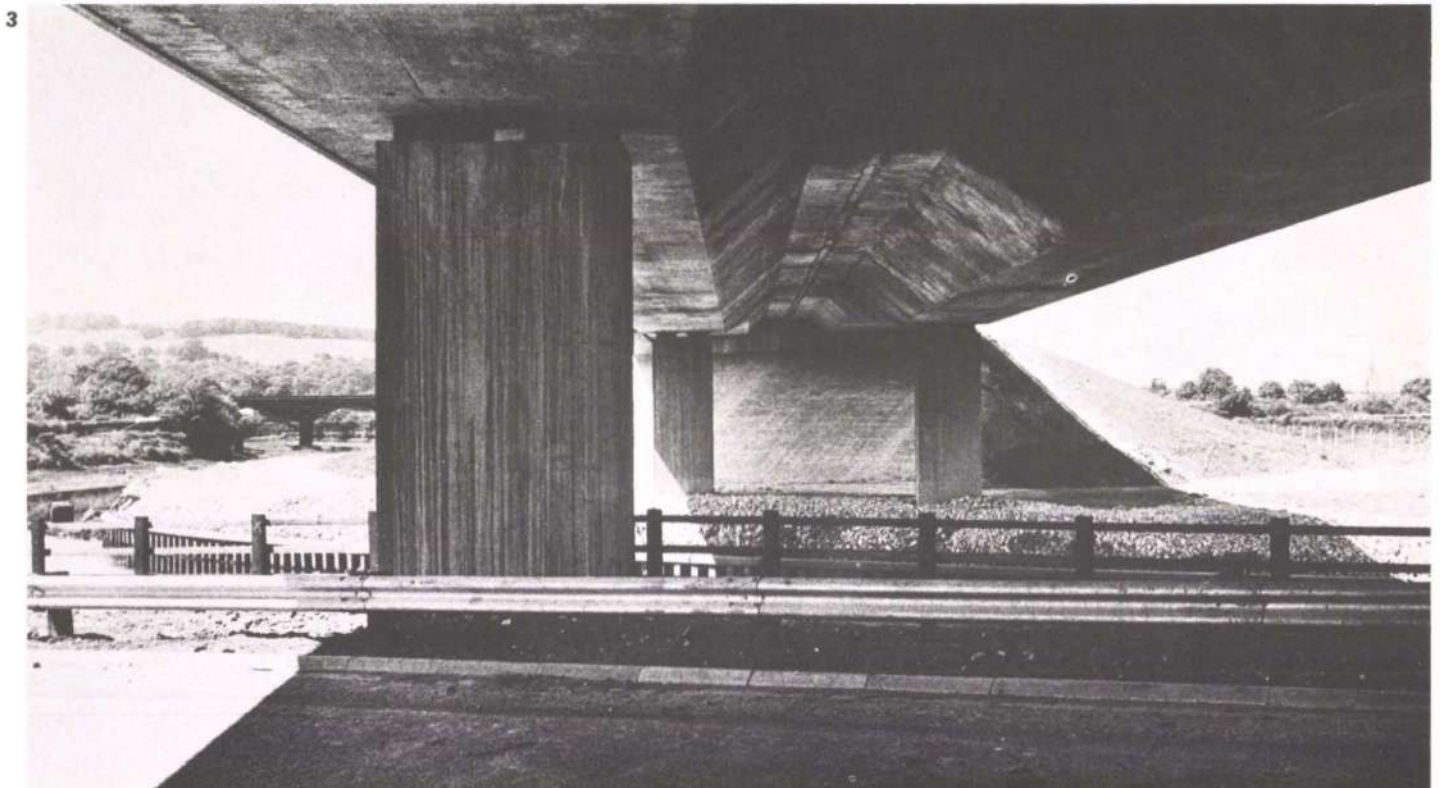
The main span of 50m over the River Derwent is a prestressed concrete box. The river is trained around the main piers.

This bridge is much larger than the others but it is consistent with them in character and in detail. (All photos: Harry Sowden)
