# THE ARUP JOURNAL

JUNE 1978

The Danish Embassy, by Ove Arup	2
Bradford Transport Interchange, by R. Stephenson	5
Guinness Breweries, Benin, Nigeria, by D. Brunt	9
Our Lady's Priory, by C. Milloy	16
Theatre Royal, Nottingham, by P. Lock	18

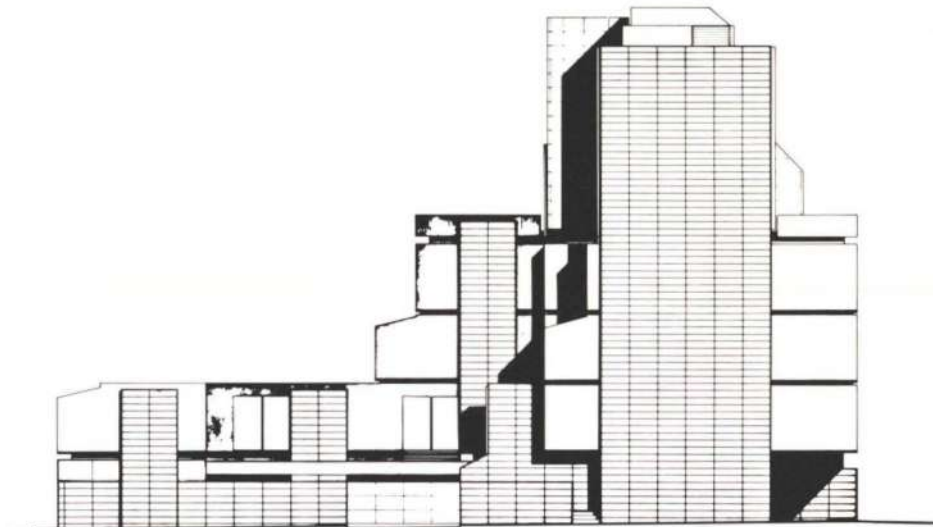
Fig. 1  
Hans Street elevation

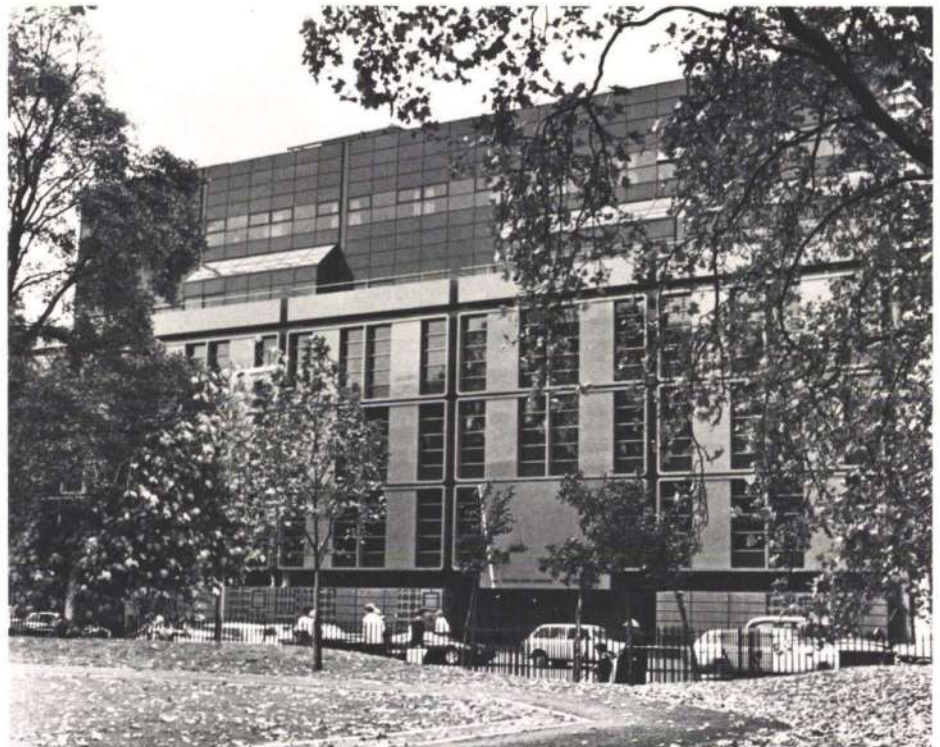
Fig. 2  
Sloane Street elevation (Photo: Colin Wade)

(1) The Cadogan Estates are of the opinion that the fifth and sixth floors (the Ambassador's residence) are out of proportion to the Chancery and Consular

Offices beneath. Furthermore the Estate considers that the separate treatment of different materials on the fifth and sixth floors is out of keeping with the proposed elevational treatment beneath.

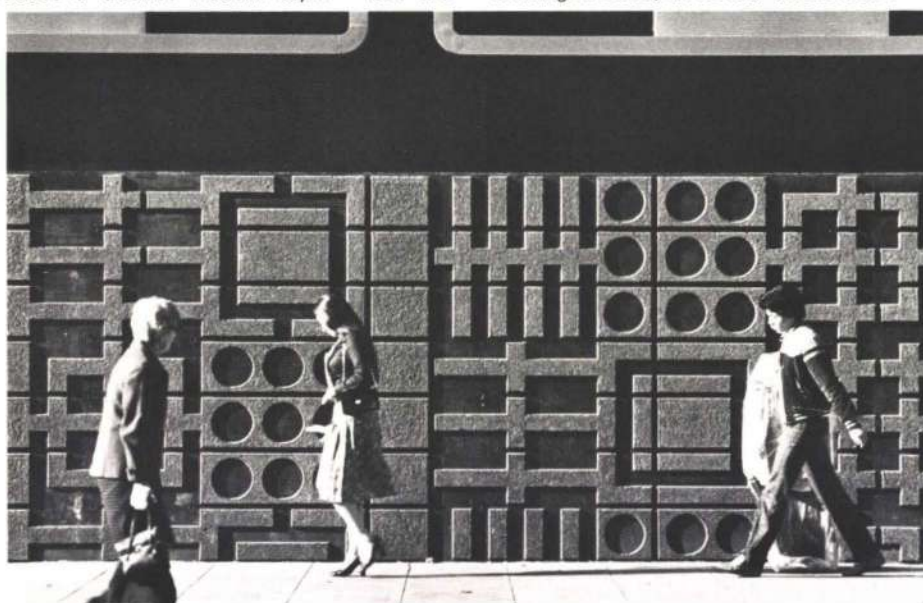
Fig. 3  
Chancery: detail of block concrete mural wall, Sloane Street  
(Photo: Harry Sowden)

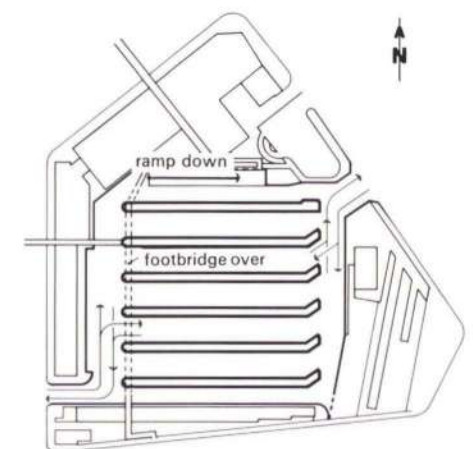
**Fig. 3** Block plan

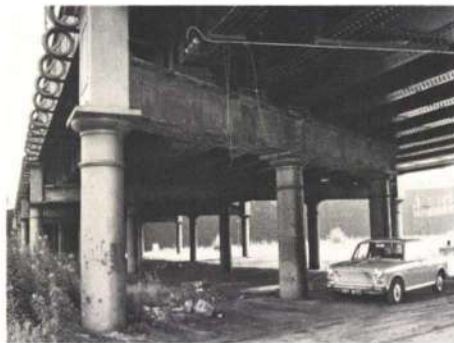
**Fig. 4**  
Croft Street bridge before underpinning  
(Photo: British Rail)

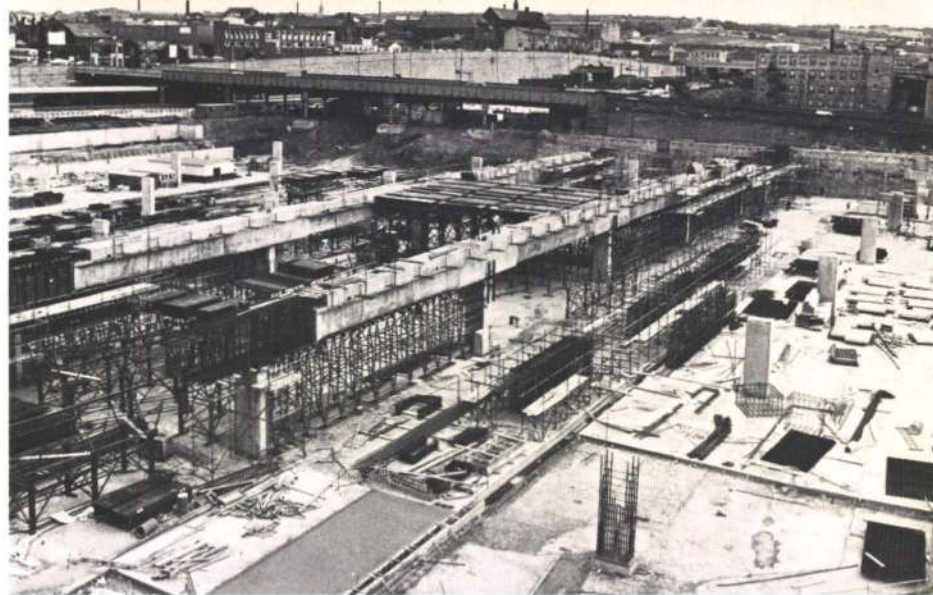
**Fig. 7**  
Bus station deck under construction with underpinned bridge and diaphragm wall in background (Photo: M. T. Walters, Mexborough)

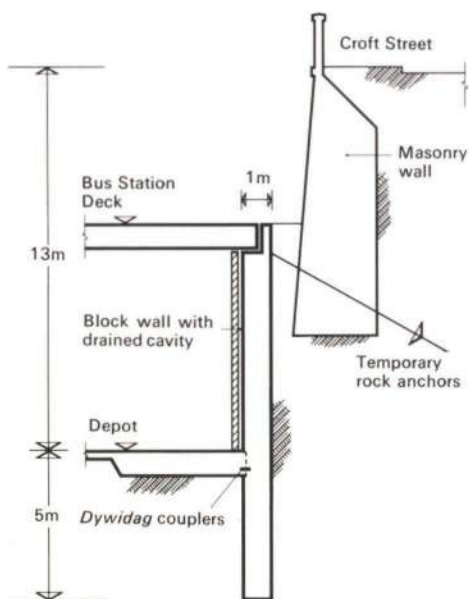
**Fig. 5**  
Section at Croft Street boundary

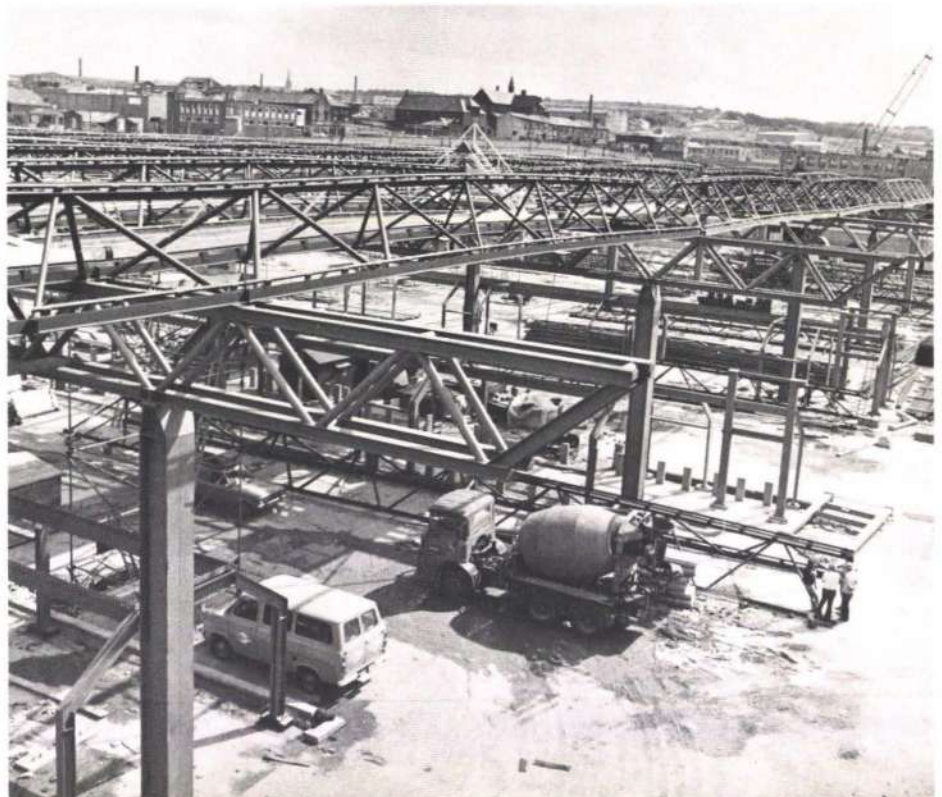
**Fig. 9**  
Main roof and passenger island steelwork  
(Photo: M. T. Walters)

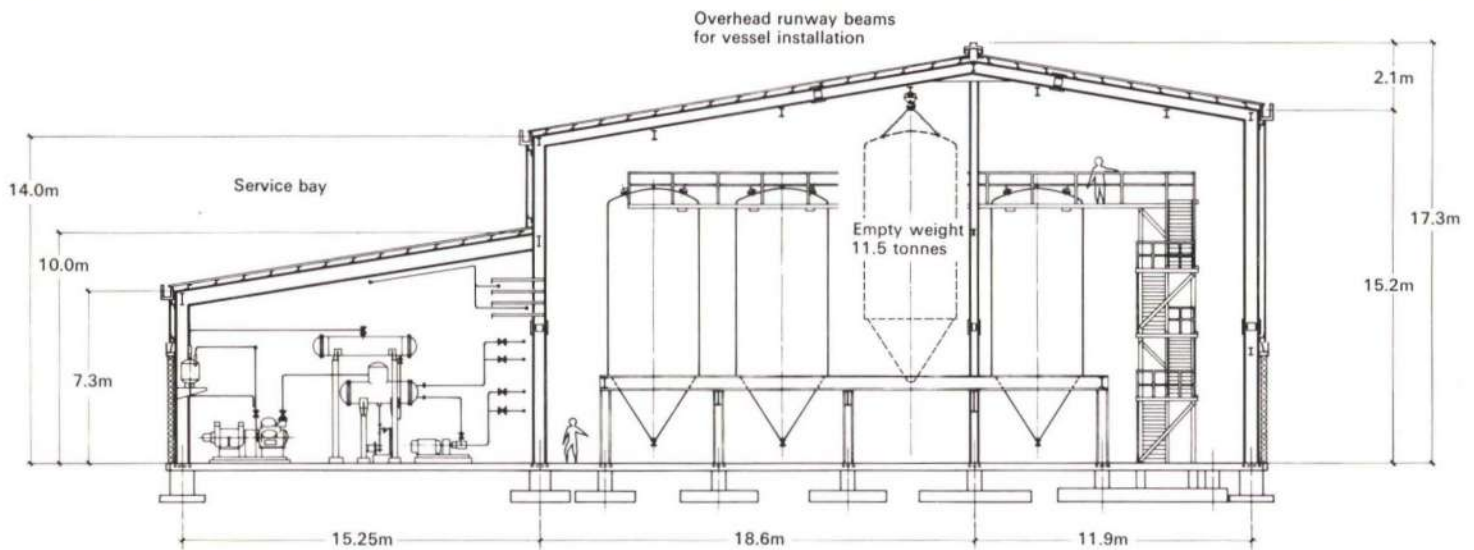
**Fig. 15**  
Typical section through the storage vessel area of the stout process building

The typical cross-section of the process building was required to envelope an area 9 m high and 45 m across, with almost  $\frac{2}{3}$  of the width taken up by the cold cellars containing horizontal vessels stacked in two vertical layers. Some thought was given to dividing the 45 m width into two roof spans, each with a bi-pitched roof, but this involved having a central valley gutter in a long building containing a lot of sophisticated plant as well as a lot of thermal insulation needed to keep the cellar temperatures down to 0 C. Although generous sizing of gutters and downpipes would reduce the risk of overflow, there would always be the danger of a tropical rain storm arising unexpectedly before maintenance staff had had the

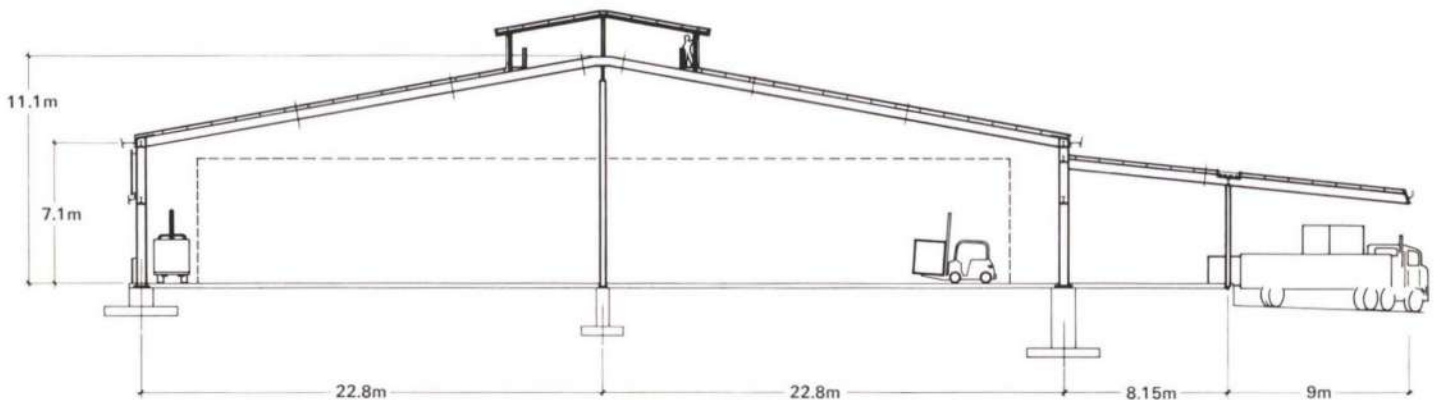
**Fig. 16**  
Section through empty bottle store

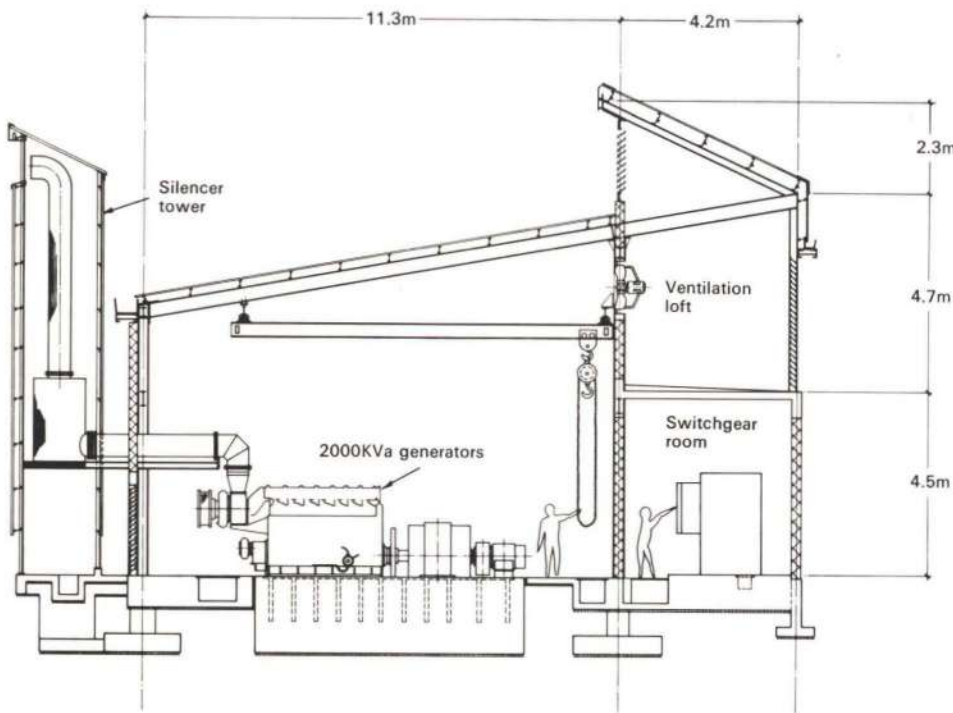
**Fig. 22**  
Section through generator house

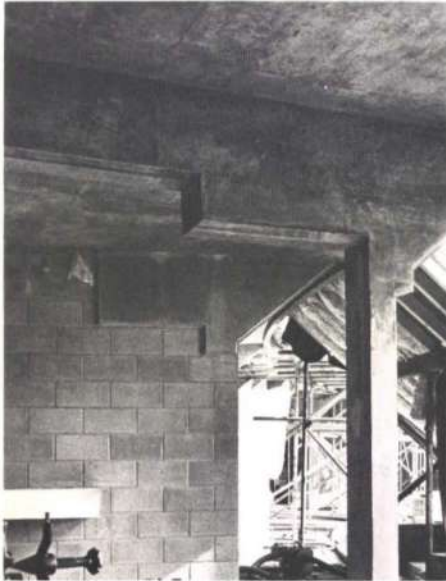
**Fig. 4**  
Detail of blockwork (Photo: Harry Sowden)

In keeping with the architectural concept it was decided to use fair-faced concrete blocks to form the main load-bearing walls, two storeys in height, and the final type chosen was an etched *Forticrete* block. To maintain the uninterrupted perimeter cloisters, fair-faced concrete corbels cantilever out from the ends of the crosswalls. Where the room lay-out did not permit the crosswall, this was replaced by a concrete column on grid and the corbel extended into a beam. The first floor slab is a conventional concrete slab with the fair-faced walls continuing up above it to support the roof.

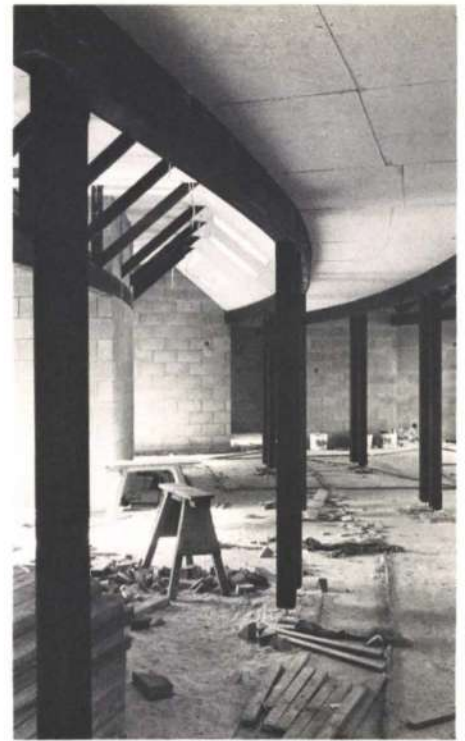
**Fig. 5**  
The curved laminated timber beams in the library (Photo: Harry Sowden)

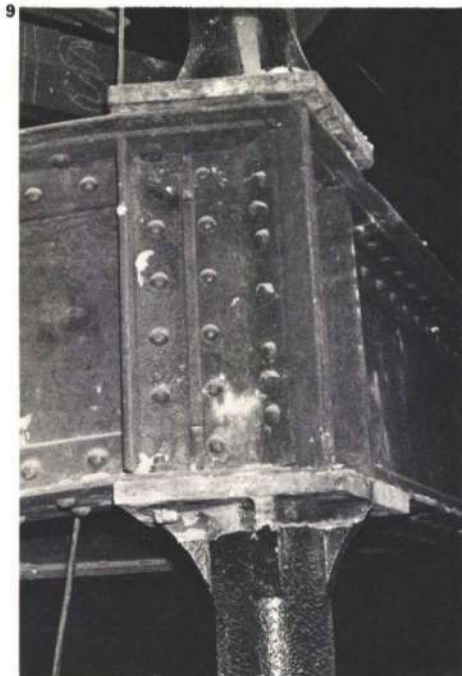
**Fig. 9**  
The original steelwork  
(Photo: Tony Broomhead)
