THE ARUP JOURNAL

JULY 1979

The Salhia complex by M. Threlfall, D. Ryder and C. Wood	2
The strength of joints in tubular lattice towers: an investigation, by E. Booth	6
Abu Dhabi Trade Centre by D. Lewis	10
Building services design in the context of security by D. Lush	13
Angel Court: cladding by L. Jones	18
Buxton Opera House by Arup Associates	22

The Salhia complex, Kuwait

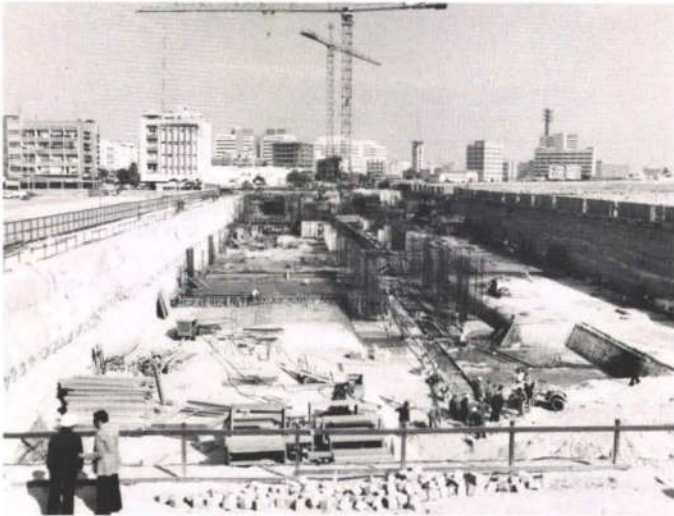
Fig. 4
The excavation at 26 December 1976, showing wellpoint dewatering (Photo: Oscar Matri, Kuwait)

Both buildings are founded on structural rafts. Except for localized soft areas the sub-soil of Kuwait is a very compact, slightly cemented sand. As can be seen in Figs. 4 and 5 the ground stands well in open excavation. In Kuwait the Government Research Station provides a free site investigation service. The operators must get very bored by their endless logging of 'N' values in the 50-100 range. Despite these high readings the Municipality had a limiting bearing pressure of 3 kg/cm². For this site they were persuaded to agree to 5 kg/cm². The more interesting raft is the one for the Commercial Centre where the 18 x 8.4 m grid imposes rather widespread column loading (maximum 12,200 kN) and core positions. The perimeter loading, which is spread longitudinally by the retaining walls, also has to be spread laterally by the raft. On the north side the external line of construction is also the building line so there is a minimal toe projection. The effect of this on the raft form can be seen in Fig. 1 by comparing it with the south side where a better toe could be provided. A similar 'edge' problem occurs down the centre of the building where the large services duct creates a very thin section of raft just where pressures are highest and easy load distribution most desirable. Distribution under the duct had to be sacrificed and a 100 mm polystyrene compressible layer provided underneath the duct to prevent the imposition of unbearably high pressures on the thin slab. The alternative of 'bending' the thick raft under the duct was unattractive for both detailing and constructional reasons. The water table lies 1.5 m above the lower basement level. Wellpoint dewatering can be seen in Fig. 4.

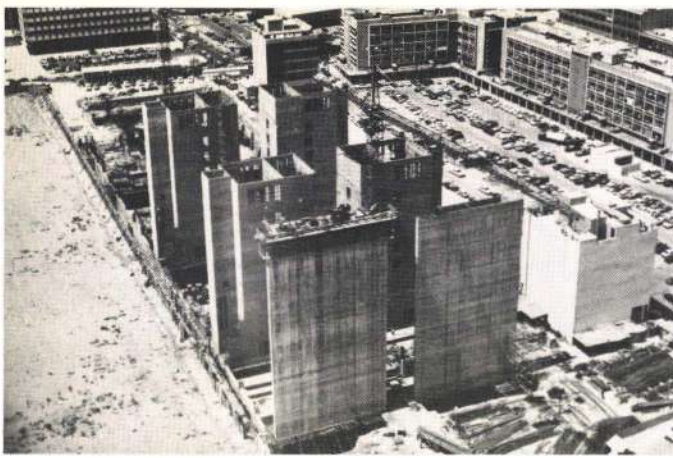
Fig. 7
The general site layout, with six slipformed cores cast and six still to be cast (Photo: Oscar Matri, Kuwait)

The general site layout for construction purposes can be appreciated from Fig. 7. The south (graveyard) side was always inaccessible and, after a short period, the opposite long side on the north was barred. The long site had thus to be serviced from the two short ends, some 250 m apart. The centre strip of the ground floor of the Commercial Centre was designed to be built quickly to act as a construction bridge along which tower cranes and vehicles could run. In the permanent buildings this deck forms the shopping mall and also has to carry fire engines. Construction of the hotel could not be readily started until enough of the Commercial Centre had been built to allow major access to be cut off at the hotel end. The Commercial Centre was started at the hotel end but progress was not quite fast enough. A temporary bridge was built across the hotel site and the hotel built around it up to ground floor level. Despite the hurried importation and stacking of building materials and the posting of a tower crane on the mall roof (suitably propped) in the Commercial Centre, hotel construction was delayed by a few weeks.

The lift/stair cores which stabilize the structure are shown in Figs 7 and 8. As can be seen they were slid ahead of the main construction. Losinger of Switzerland were the sub-contractors for the sliding formwork and expertise. The conceptual design had positioned the expansion joints of the building just inside one of the outside walls of the core. In the free-standing mode the cores thus had one loose wall, so temporary steel braces were fitted to stabilize the box. In addition to this vertical severance the cores had the considerable vertical discontinuity illus-

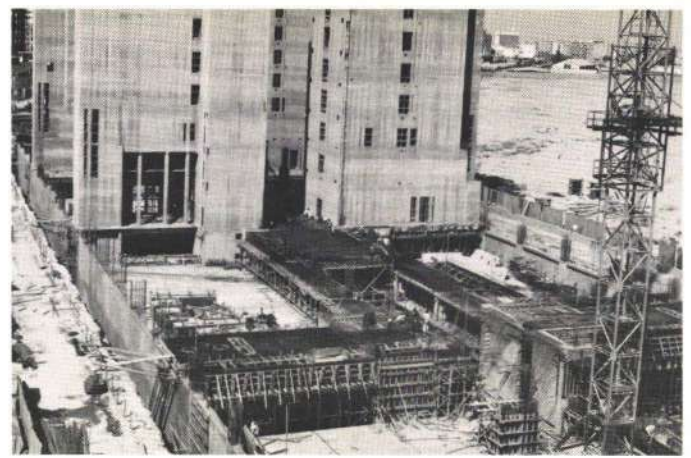
Fig. 8
Close-up of slipformed cores under construction, 17 April 1977 (Photo: Oscar Matri, Kuwait)

trated in Fig. 8. The large gaps in the lower walls provide the necessary horizontal circulation at car parking and main shopping floors. So much of the basement storeys is removed that sliding was started at ground floor level. The photograph shows the heavy steel propping which was required temporarily until the core wall was completed and supported by the complex column on the outside wall. Other temporary devices such as false concrete columns, later cut off, were required to give structural integrity to the core whilst it was at low level and before the solid upper parts had been cast.

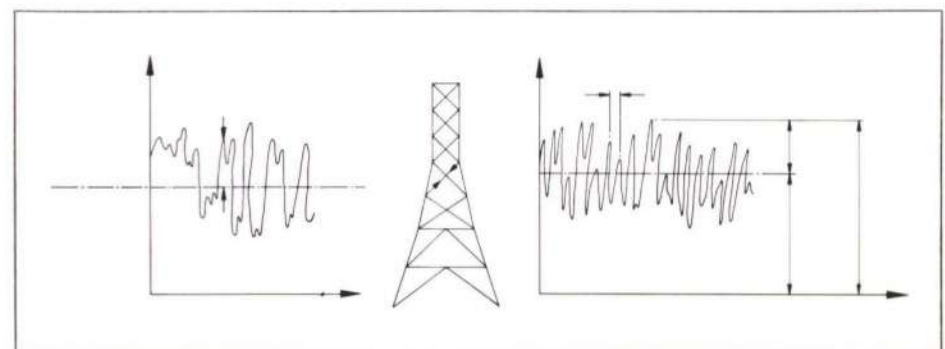
Fig. 7
Mean hourly and fluctuating components

The approach was a probabilistic one and idealized the pattern of wind gustiness, and hence structural response, in the following way. Both excitation and response can be split into a mean component, averaged over an hour, plus a random fluctuating component – see Fig. 7. These random fluctuations were assumed to follow a 'Rayleigh distribution' (see Fig. 8). It can be shown mathematically that the fatigue damage caused by a Rayleigh distributed stress spectrum depends only on the frequency and RMS (root mean square)

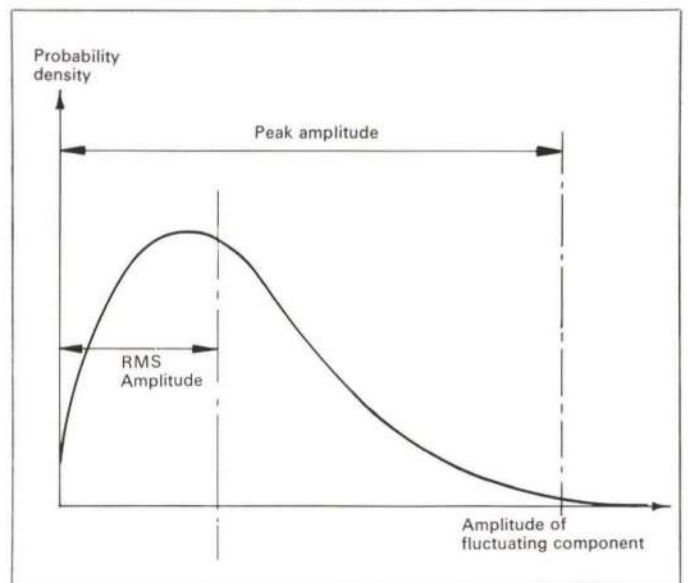
Fig. 8
Rayleigh distribution

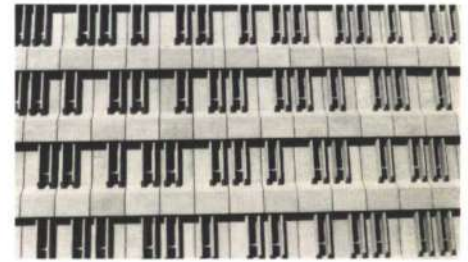
Fig. 6
Detail of cladding panels
(Photo: Bob Walster)

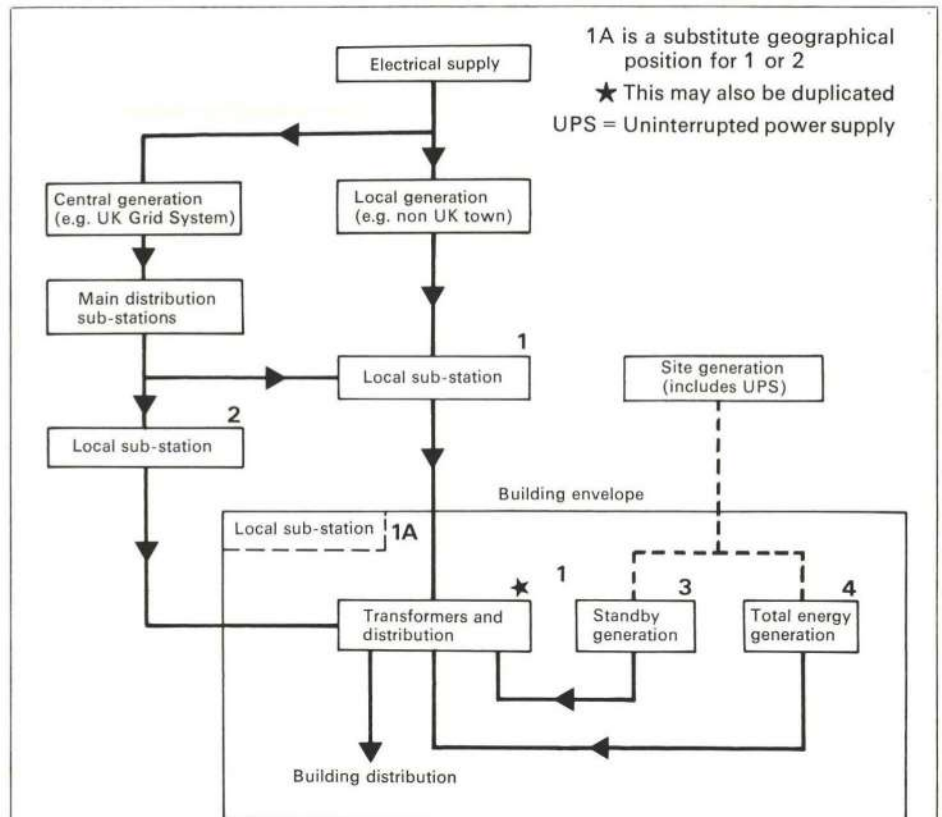
Fig. 4 Possible electrical supply situations

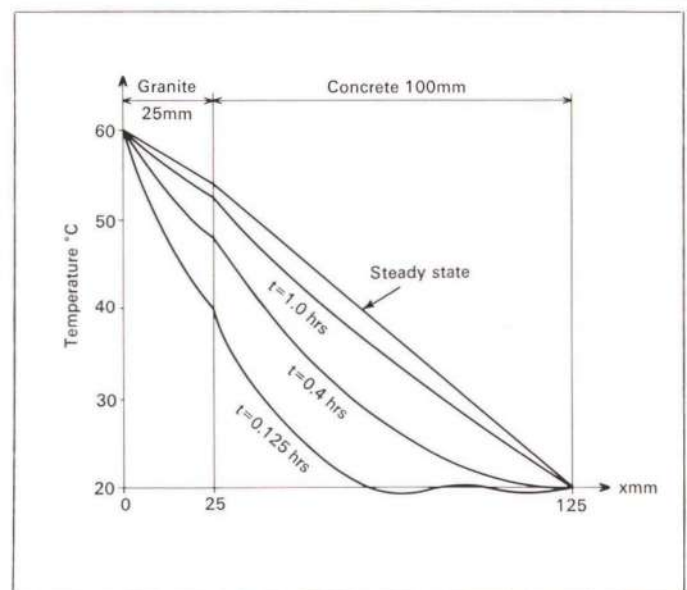
Fig. 1
Temperature profiles
at various times

In the design it was assumed that the total unit was initially at a temperature of 20°C and that the external face of granite suddenly attained surface temperatures of 60°C in the hot range and of -8°C in the cold range. As the maximum differential movement is time-dependent, i.e. the steady state temperature gradient is not the critical condition, this instantaneous raising of the surface temperature is a somewhat extreme boundary condition. Fig. 1 indicates temperature distributions across the composite section with respect to time for a sudden increase of surface temperature.
