# THE ARUP JOURNAL

Vol. 19 No. 1 April 1984 Published by Ove Arup Partnership 13 Fitzroy Street, London W1P 6BQ

# The Old Vic is back!

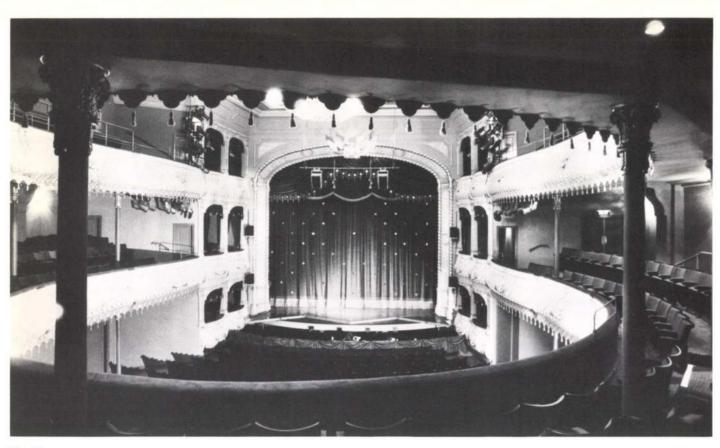
#### Fig. 15

Auditorium with reinstated boxes and circle seating. (Photo: Ove Arup & Partners)

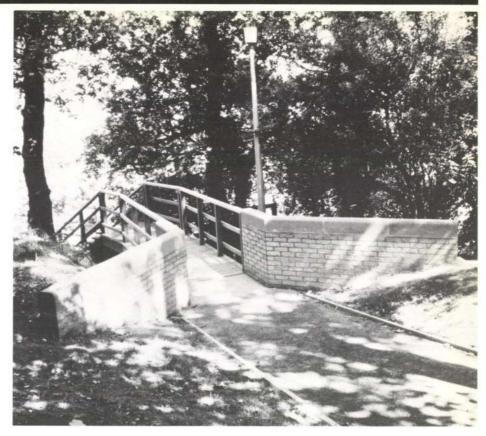
#### Fig. 1

The approach to Wylam footbridge showing the abutments in hand-made brick

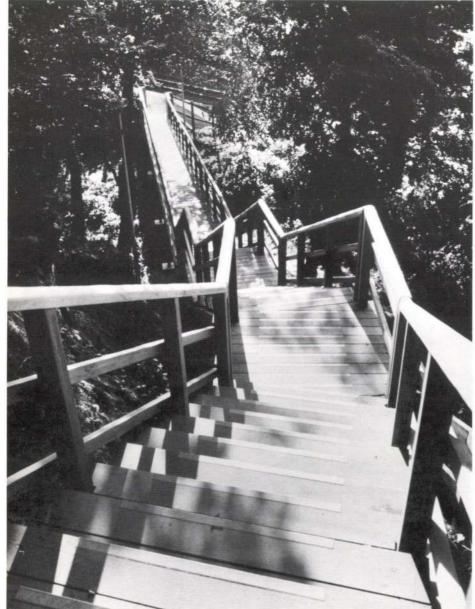
#### Fig. 2

Wylam footbridge: the three short flights of stairs down to the bridge

A scheme was developed using a gentle ramp and three short flights of stairs. The structure was deliberately designed to avoid 'liveliness' and to give a feeling of confidence. All the timber is dressed, to make the form very precise. We tried where possible to allow shop prefabrication, and so the stringers and handrails were designed so that they could be made as a unit.

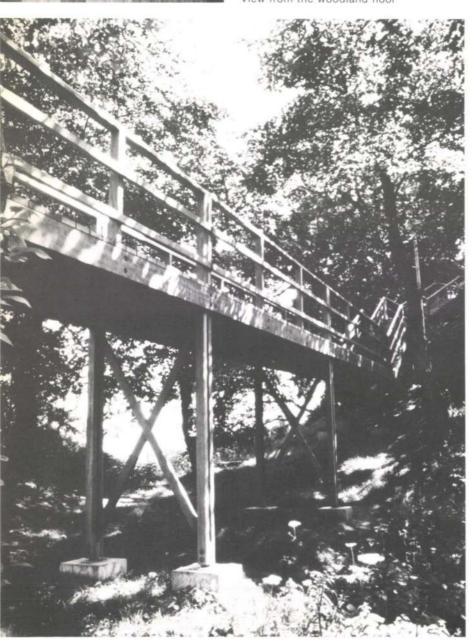
Fig. 5 Wylam footbridge: View from the woodland floor
