# THE ARUP JOURNAL

WINTER 1985

The structure, by Jack Zunz, Michael Glover and Tony Fitzpatrick	2
The basements and substructure, by Chris Humpheson, Tony Fitzpatrick and John Anderson	27
The derivation of overall design loads from the wind tunnel test results, by Michael Willford	37
Development and use of a cementitious barrier coating, by Turlogh O'Brien and Allan Marsden	38
Project planning, by Peter Bolingbroke	40
Seawater intake system	42

## The structure

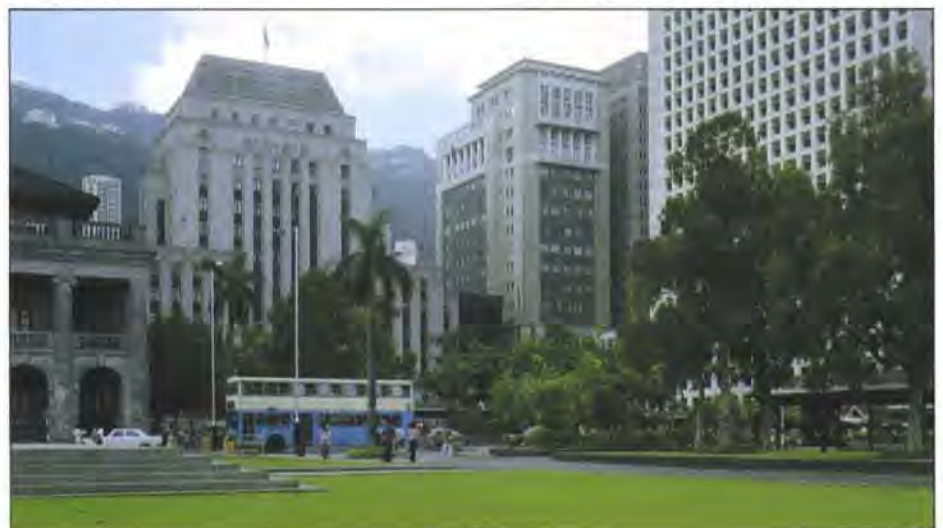
Fig. 1

Significantly the building, which was opened in October 1935, formed one of the most up-to-date and completely equipped buildings in the Far East (Fig. 1). Although much material and equipment came from England, the whole enterprise was completed in two years under the direction of Messrs. M. H. Logan and L. E. Amps, who were not only the designers of the structure but were also responsible for the management of construction.

Hongkong Bank 1935 headquarters (Photo: The Hongkong Bank)

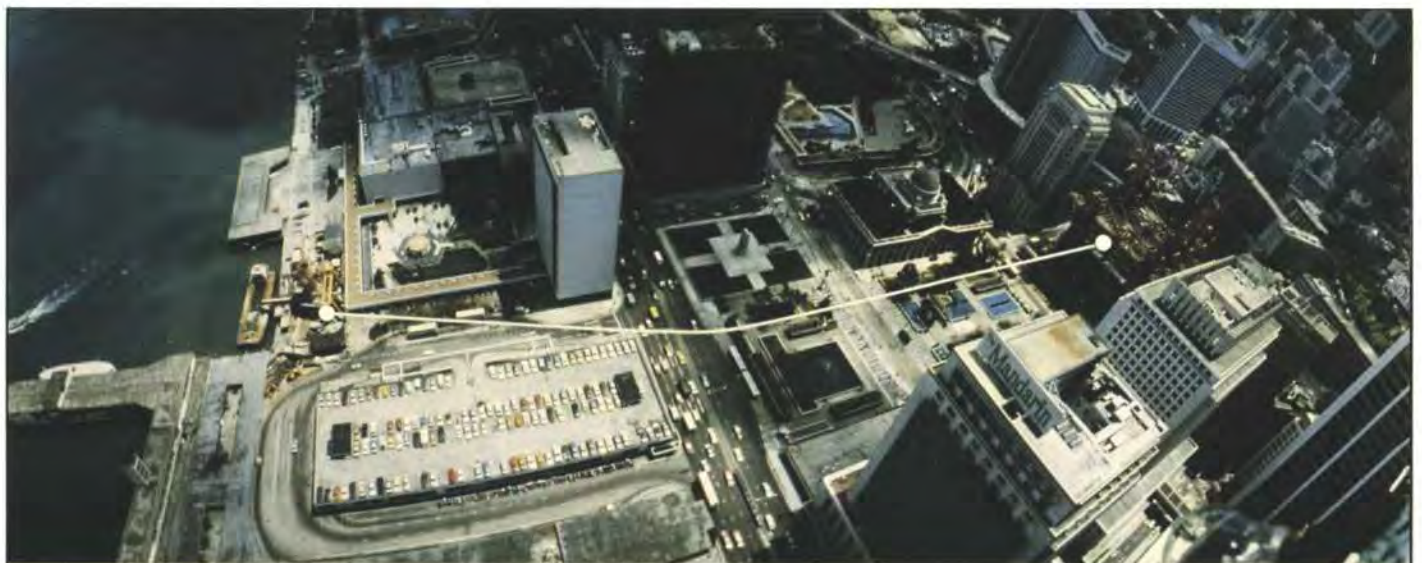
**Fig. 12 below**  
Seawater tunnel alignment

Located in the south-east corner of the lowest basement level is the entrance to the seawater tunnel. 6m in diameter and driven in the massive granite at a depth of up to 75m, the tunnel contains 700mm diameter pipes bringing seawater from the harbour for the building's air-conditioning and flushing systems.

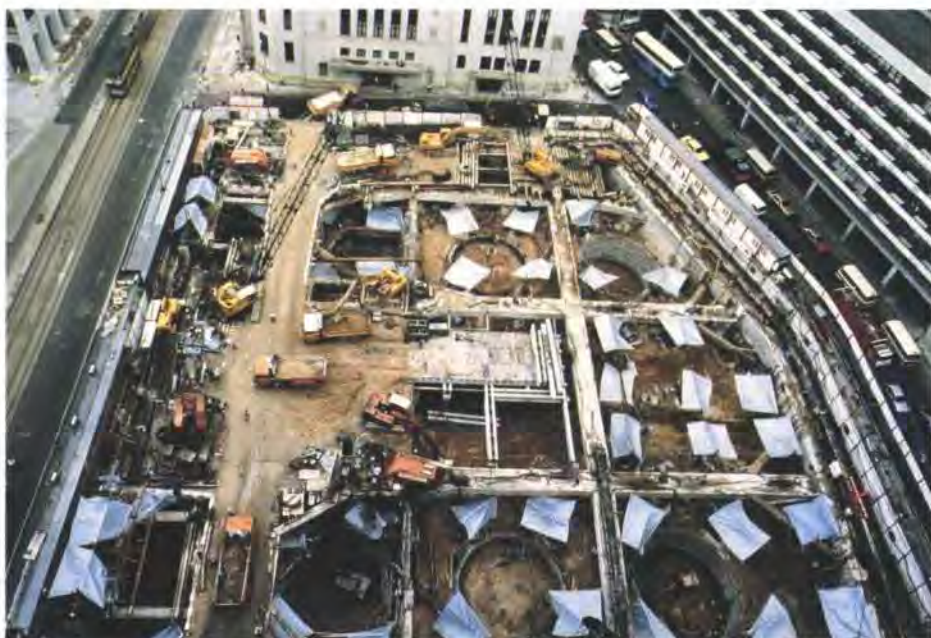
An arrangement consisting of 10m internal diameter access caissons was adopted. The access caissons were sunk around each mast from ground level to the lowest basement, and from their base were then dug the individual caissons to form the mast foundations. Fig. 16 shows the access caissons at the start of excavation.

Fig. 16  
Access caisson excavation (Photo: The Hongkong Bank)

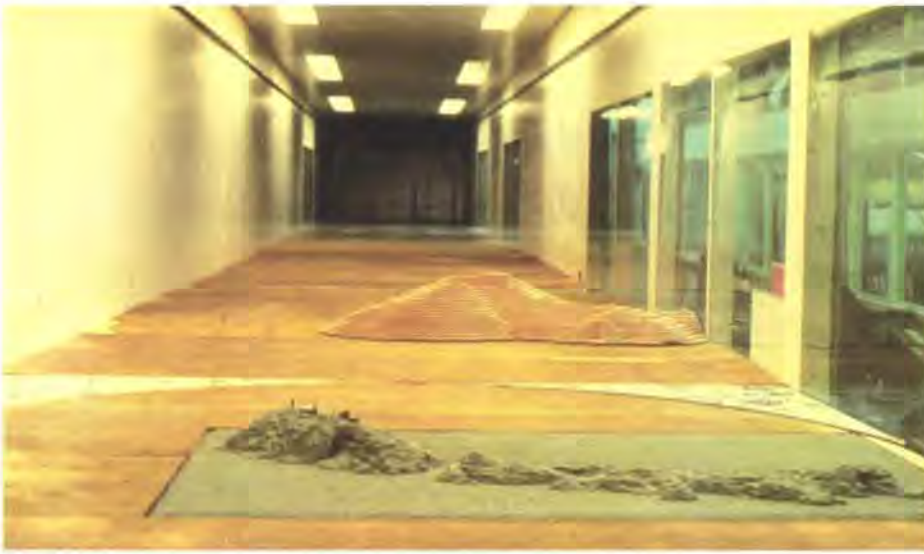
**Fig. 22**  
Wind tunnel test of Waglan Island

The wind records at Waglan Island formed a particularly important part of the assessment. Located some 6 km off the south-east tip of Hong Kong, the island is small, exposed and steep sided, and the anemometer at the top provides reliable measurements for the full range of wind directions. The problem of relating the measurements to gradient height was overcome by modelling the island in the wind tunnel (Fig. 22) in order to obtain corrections for the anemometer reading for each wind direction. The anemometer has been relocated three times since its initial installation and each position was calibrated.

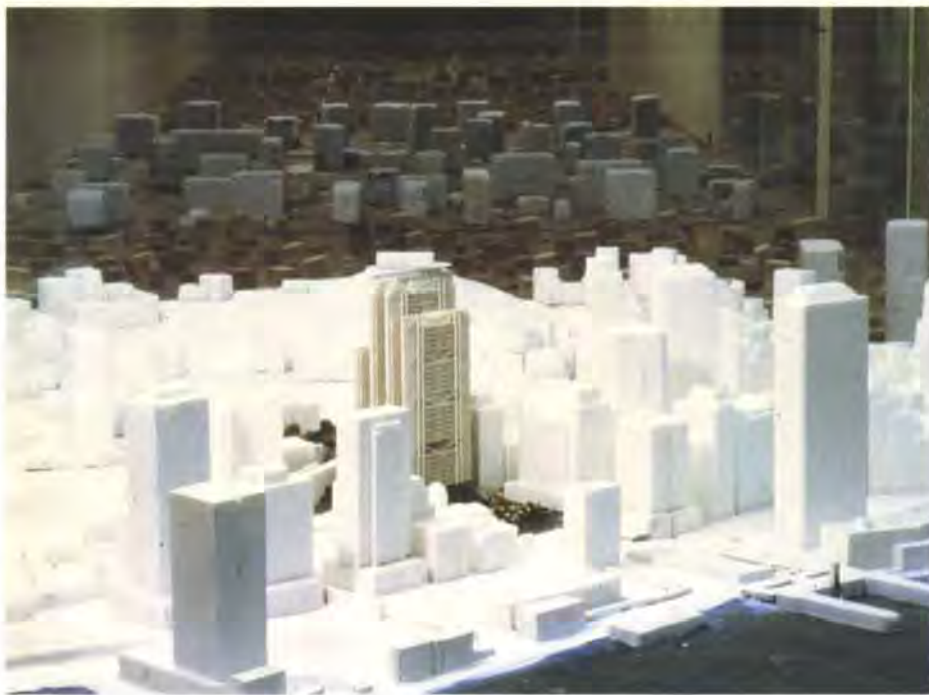
**Fig. 27**  
Proximity model

This model of the building was tested in the 'proximity model' for the incident winds at 10° azimuth intervals. The peak pressure and suction coefficients found for each direction were integrated with the directional probabilistic wind climate models to predict the 100-year return period pressures. This study showed that the statutory design wind pressures for cladding would be adequate and indeed conservative for this building, even after allowance was made for internal pressures and for the variability and uncertainty inherent in the predictions.

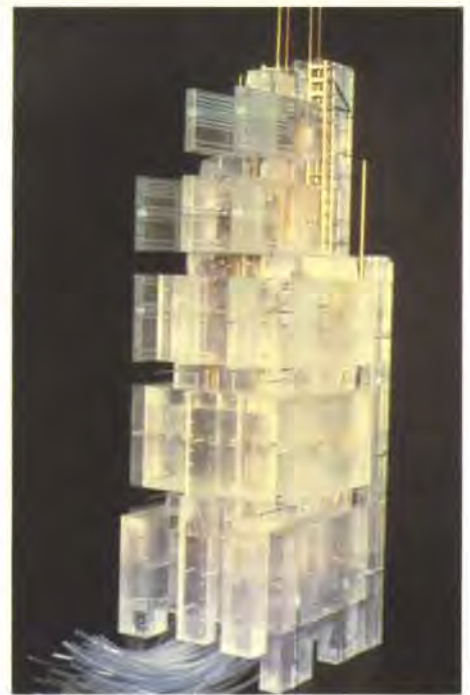
A 1:200 model of the base of the building was constructed, and the flow patterns previously found using the 1:500 pressure-tapped model were simulated at this larger scale. Various arrangements of canopies and partial closures of the plaza area were investigated in an interactive design procedure with the architect. Extensive investigations were also made of the feasibility of jet curtains at the north and south ends of the plaza opening to control the flow of wind below the building.

**Fig. 28**  
Surface pressures model

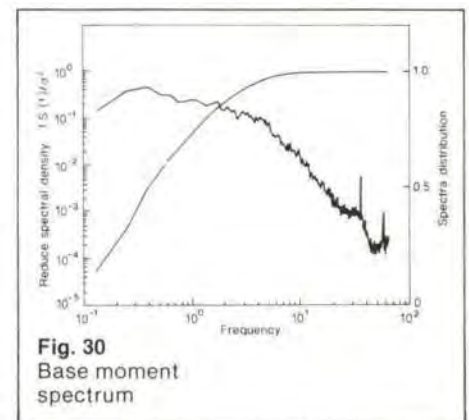
**Fig. 30**  
Base moment spectrum

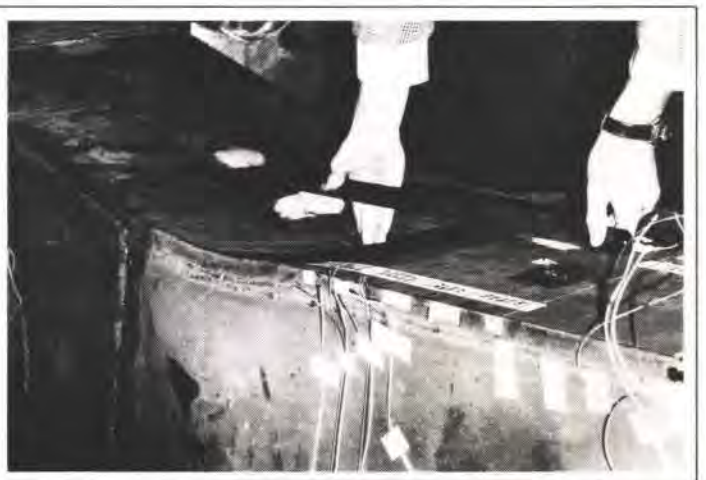
The main frame structural steelwork prototypes consisted of four typical key details, illustrated in Fig. 35. The concept was to fabricate the test pieces using the pro-

cedures set down for the production elements and then to load them as nearly as possible with the expected design forces, firstly in the working load range and then to destruction. Although the tests were intended primarily to confirm final designs, in some instances alternative details were tested and the final design decisions taken in the light of the test results.

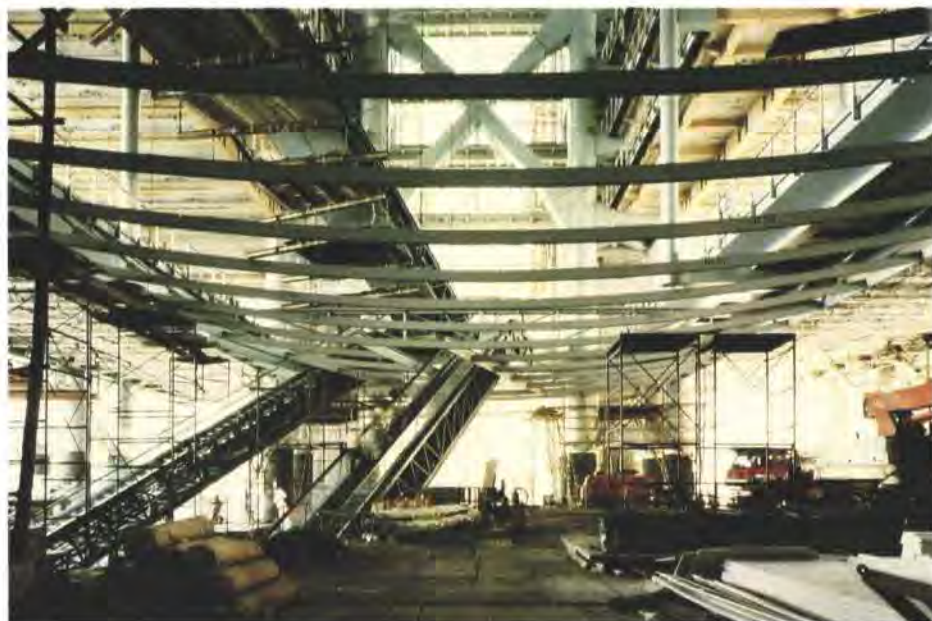
Fig. 46  
Glazed soffit to level 3 (Photo: The Hongkong Bank)

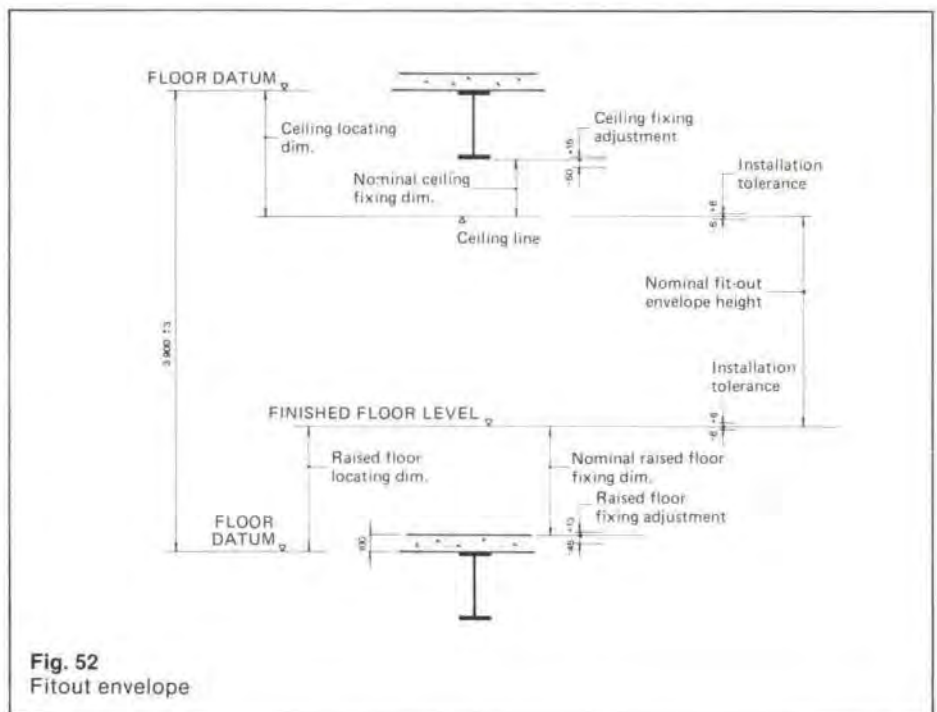
Fig. 52  
Fitout envelope

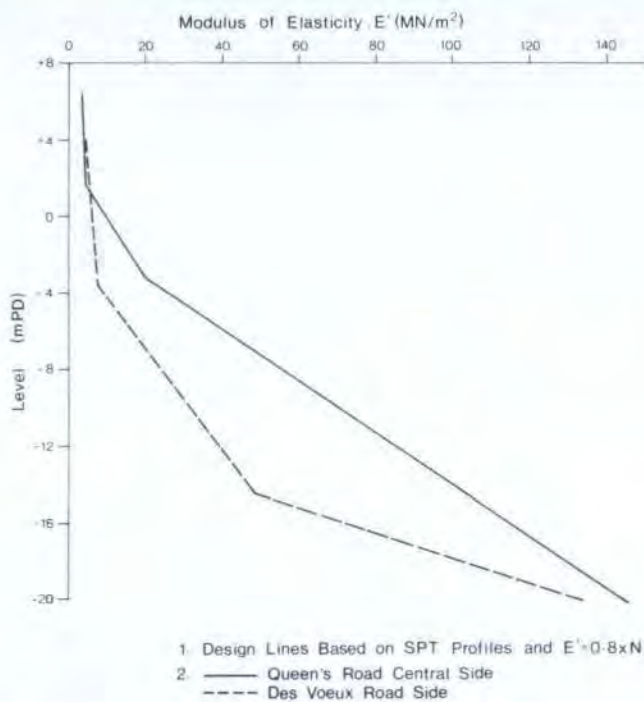
**Fig. 4**  
Variation of soil modulus of elasticity with depth

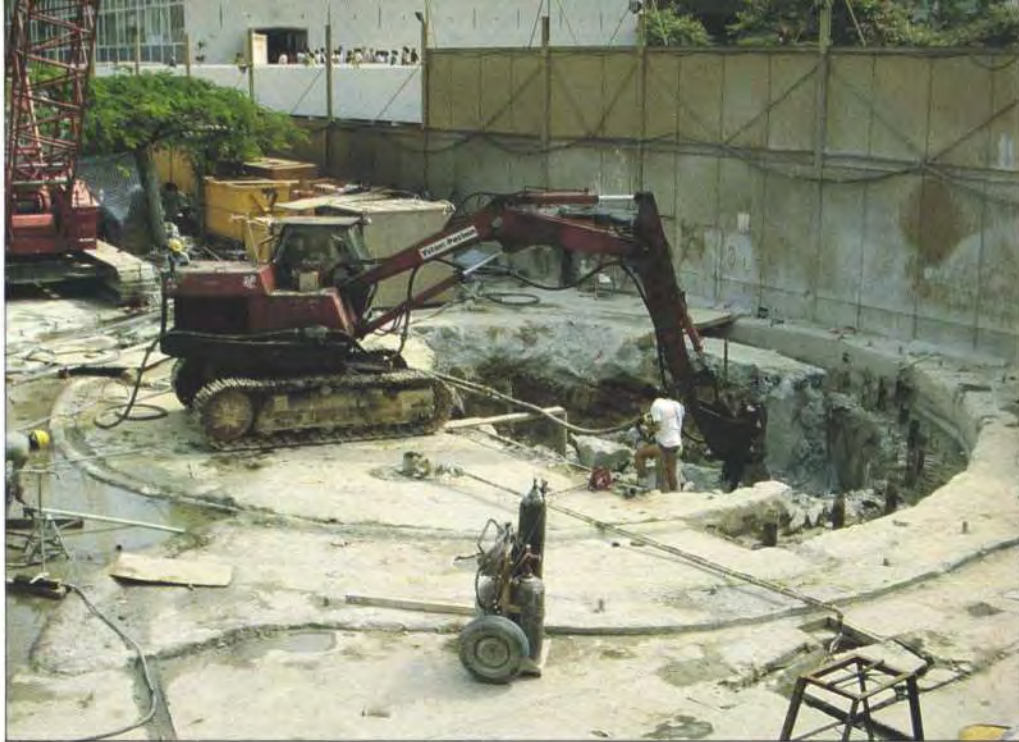
1△

- 1 Excavation of Shaft no. 2 at Star Ferry
- 2 Upper half of Shaft no. 2
- 3 Drilling probe holes ahead of the face to detect water
- 4 Tunnel excavation
- 5 Mobile shutter for concrete tunnel lining
- 6 Lined tunnel with pipes and cables installed
- 7 Seawater pipes at base of Shaft no. 2
- 8 Shuttering and reinforcement at the tunnel's junction with Shaft no. 2
- 9 Flanged joint and spacer for valve installation on seawater main
- 10 Base of Shaft no. 2
- 11 Seawater intake chamber with twin cup screens
