Mass timber fire safety

2021 Experimental series

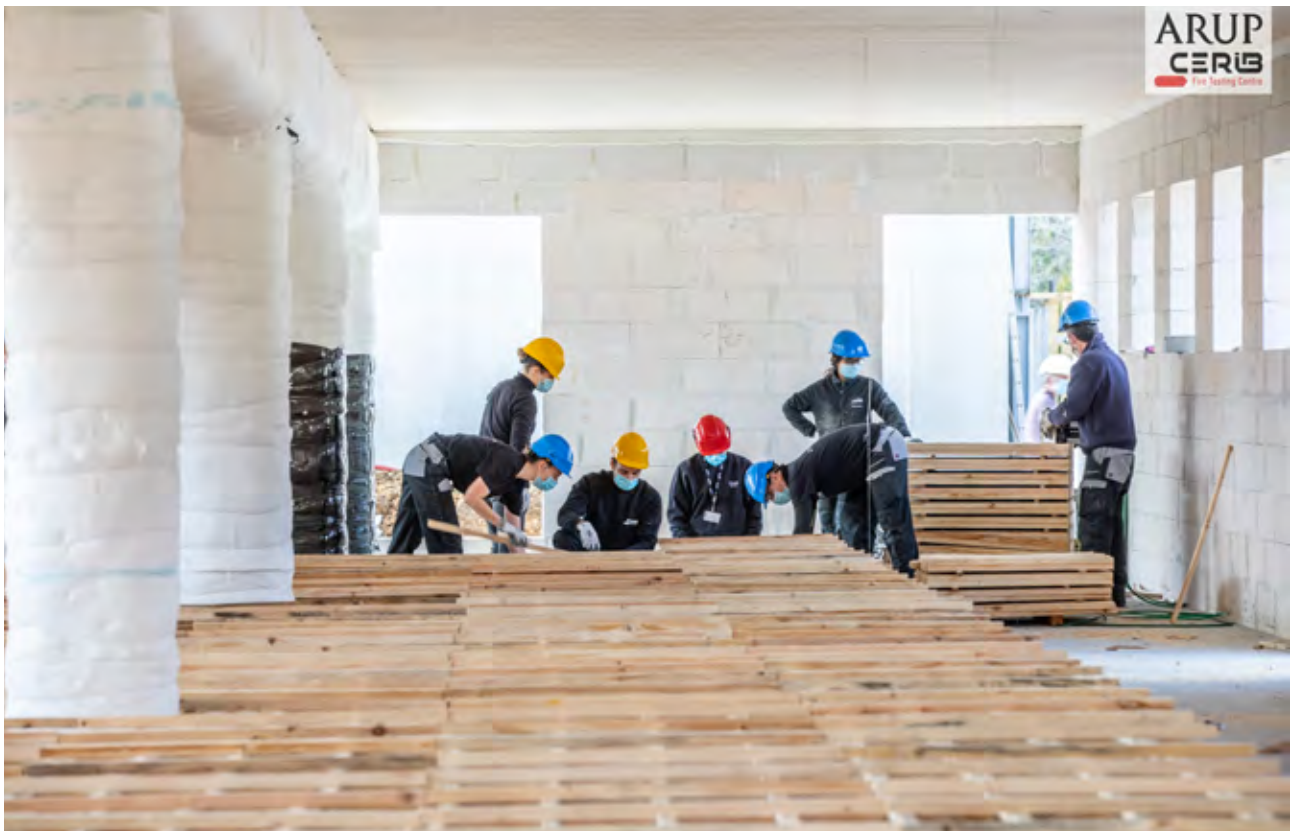
Figure 1. The purpose-built facility 11m wide, 35m long and 3m in height, shown set up for Experiment one. The team are stacking the fuel crib within the compartment to exact specifications.

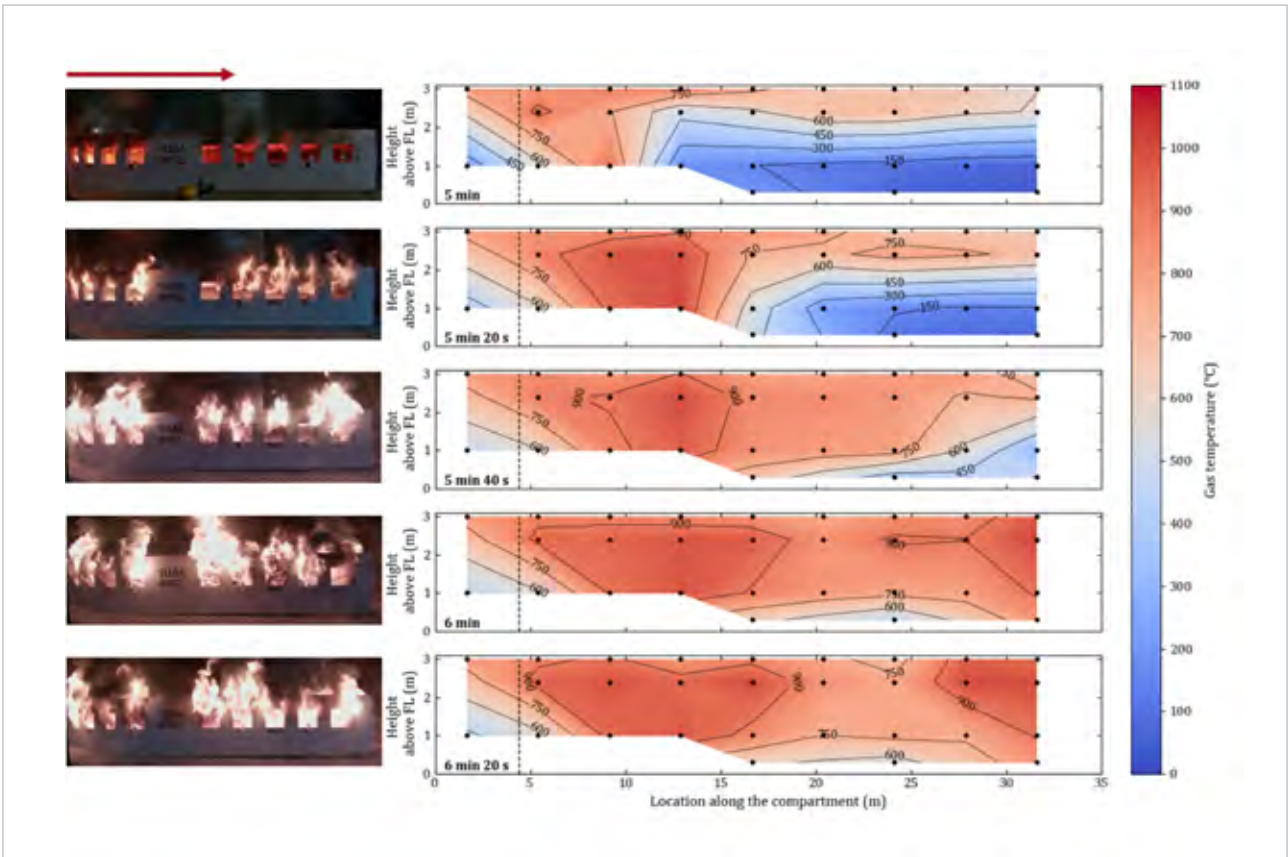
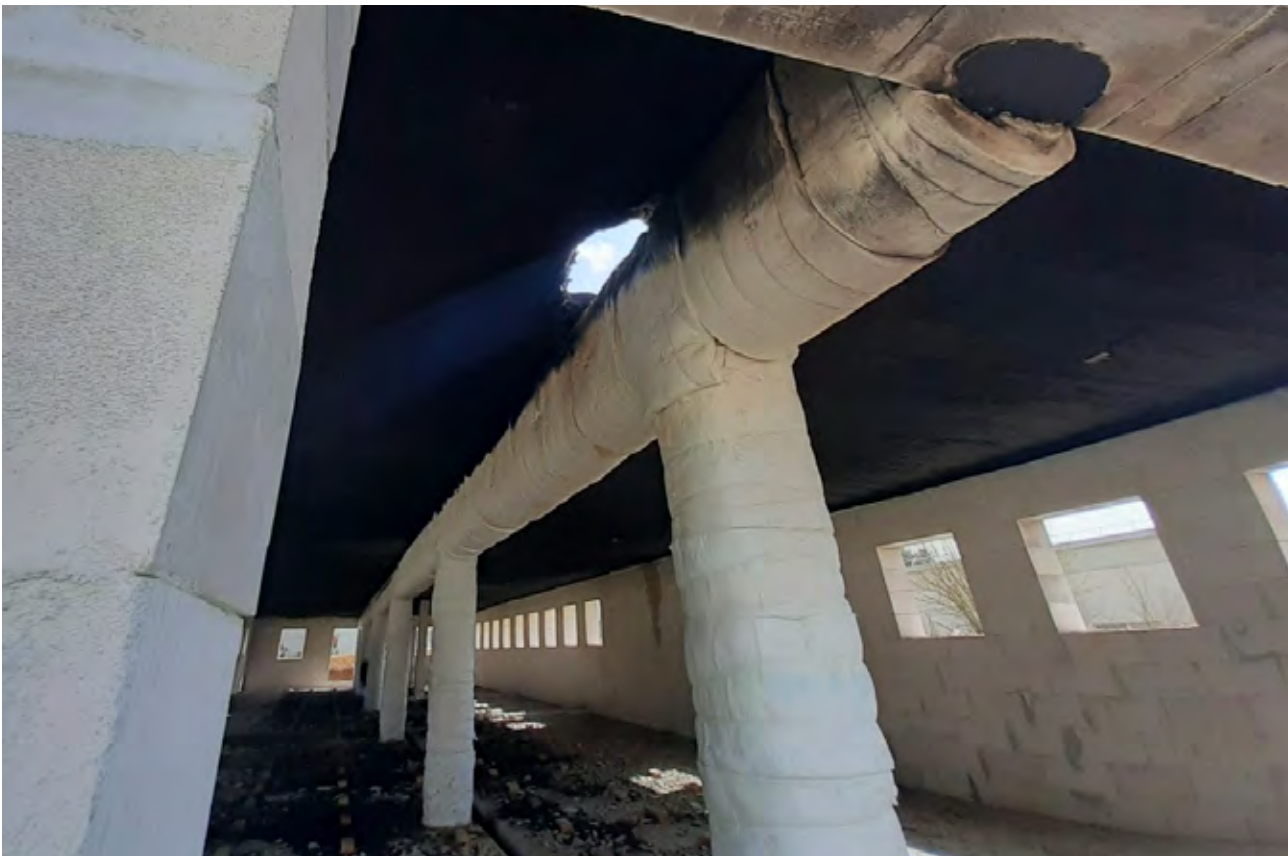
Figure 2. Vertical temperature distribution down the centreline of the compartment presented at various times from 5 min (top) to 6 min 20 seconds (bottom) after ignition. Black dots indicate location of thermocouples, while the black dashed line gives the ignition location (near the 4m mark). The photographs provide a visual of the compartment fire at the time of the adjacent contour plot.

Maximum temperatures occurred over a range of heights throughout the compartment, not just near the CLT ceiling, confirming previously published research on CLT fire behaviour (see figure 2).

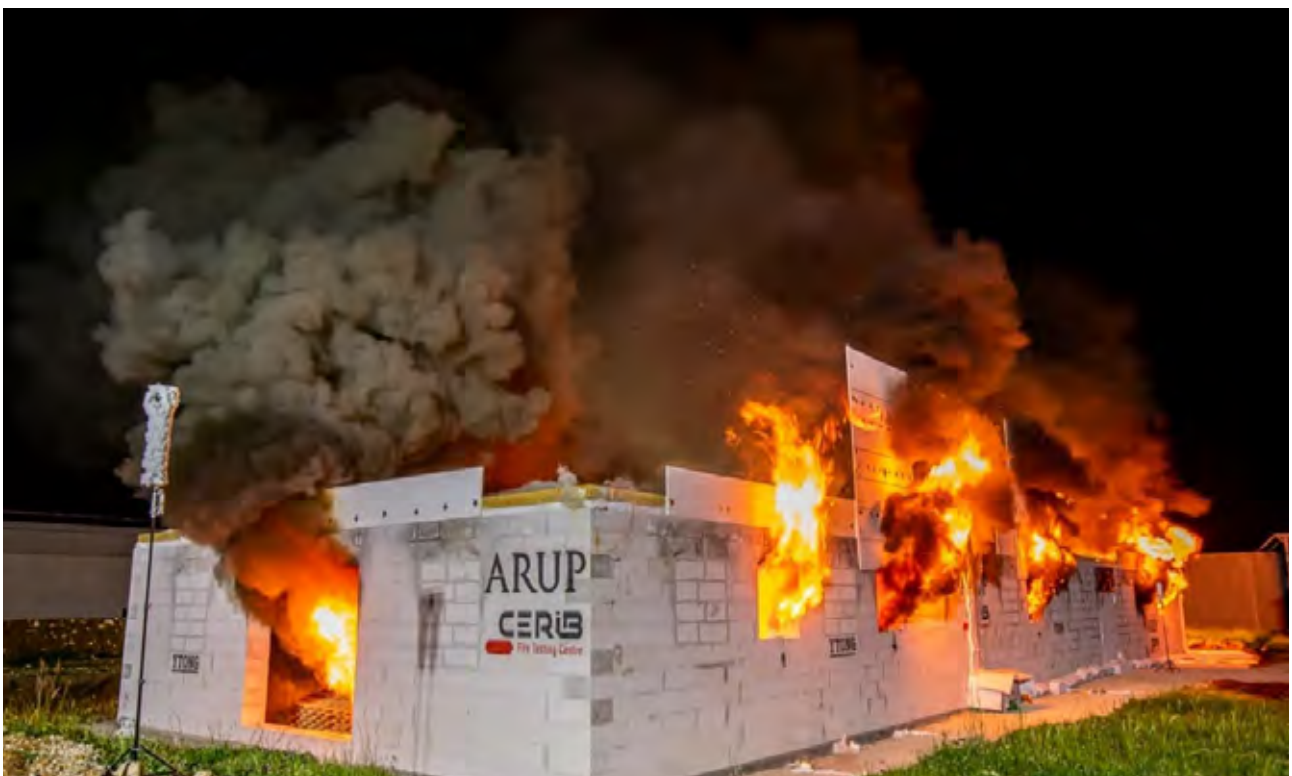
Figure 4. Photo from experiment two showing extensive external flaming from openings, as the fire reaches the end of the compartment. Wooden crib at the end of the compartment has not yet fully ignited.

During this prolonged burning phase, flame extension from the windows and doors was significant (see figure 4). As occurred in the first experiment, after a period of time the fire in the wood- crib reduced and flaming ceased at the CLT.

A portion of the fixings were loaded with concrete blocks to resemble their expected design load. Adjustments were made to instrumentation to account for the CLT protection. Again, no fire-fighting intervention was undertaken within the building thereby enabling a detailed study of the long-term fire decay and smouldering behaviour of the CLT and glulam, including behind board protection and around services fixings. Initial observations from the experiment indicate that the position of the encapsulation delayed the ignition of the ceiling, however once flaming of the CLT was sustained, fire spread along the ceiling at a similar rate to the first two experiments. Due to the delayed ignition of the CLT, the fire initially spread slowly along the crib, and resulted in a longer and less severe fire when compared to the first experiment. During this prolonged burning phase, flame extension from the windows and doors was smaller both in extent and height when compared to the first two experiments (see [figure 4](#) vs [figure 11](#)).

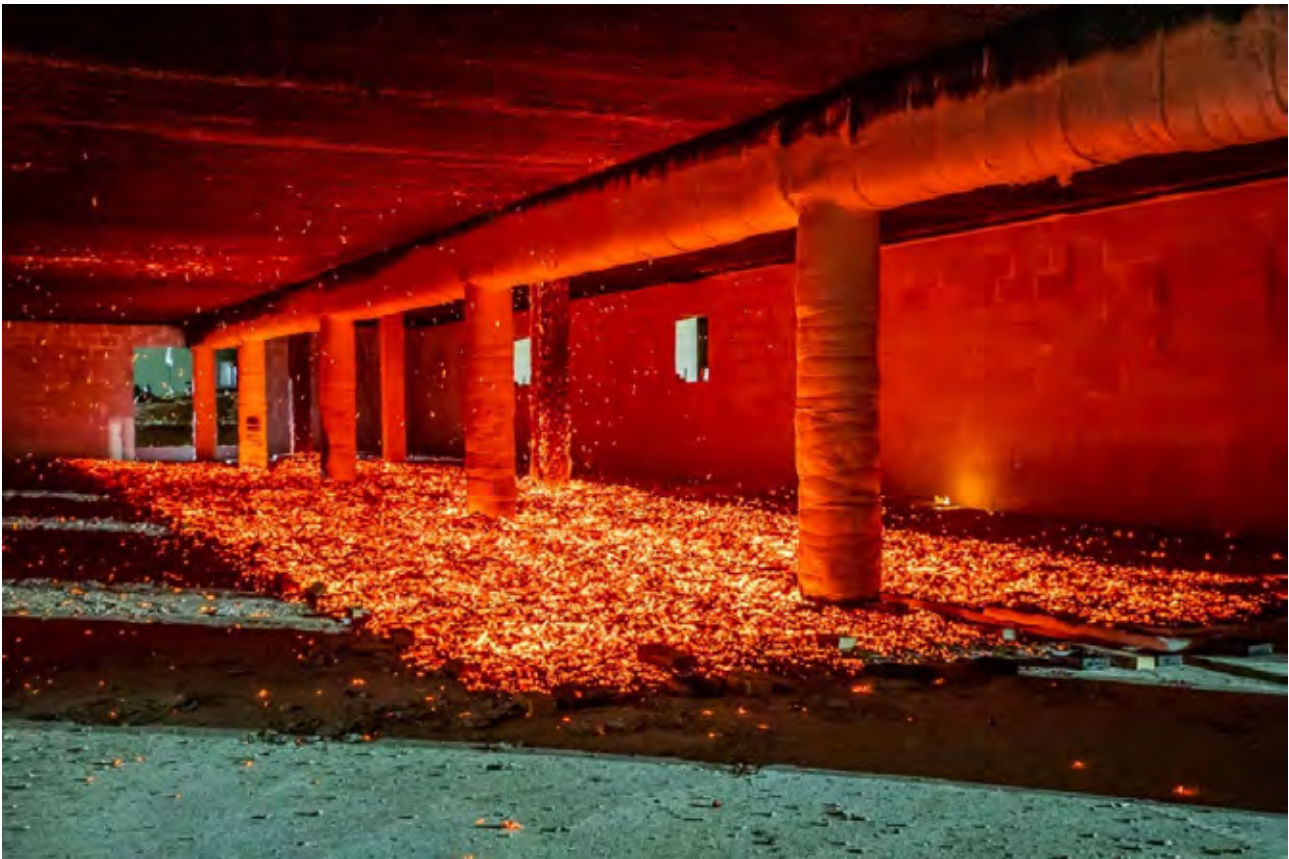
Figure 5. Photo from experiment two showing glowing embers remaining in the wooden crib, with localised flaming continuing at the base of one of the glulam columns.

Flaming was still visible at the columns for some time when there were only glowing embers remaining on the floor (see figure 5). Without firefighting intervention, small pockets of CLT again continued to smoulder for hours, eventually breaching the CLT thickness (see figure 6), with some pockets also transitioning back to flaming combustion. Smouldering also continued for several hours in one column, resulting in the loss of most of the cross section at the base of the column.

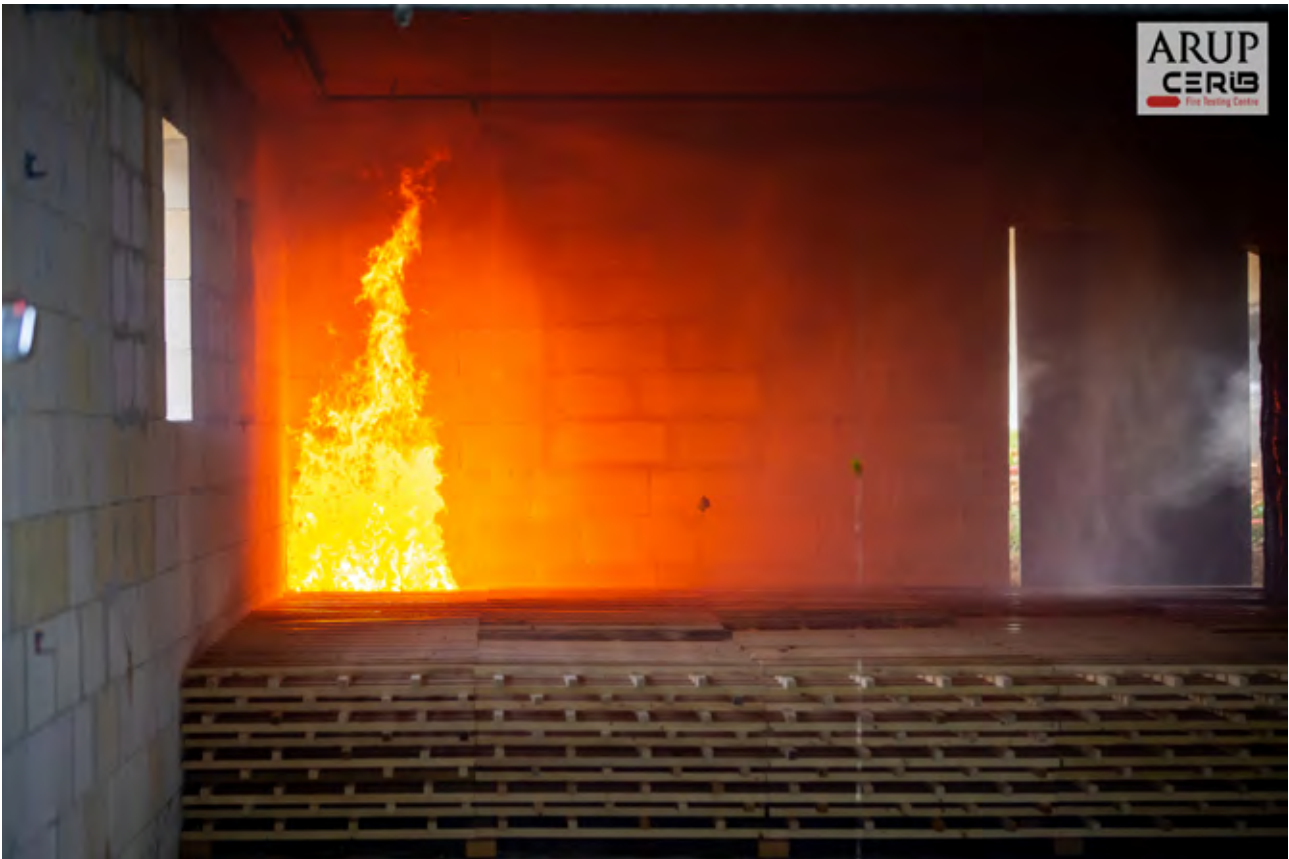
Figure 8. Ignition of the wood crib at the corner of the building, and activation of suppression system.

The third experiment was conducted on the 4th of November, 2021, with the construction being identical to the first experiment, with regards to the structure and exposed timber. For this experiment a commercially available automatic low pressure water mist suppression system was installed to cover the area of the wooden crib. The fuel was amended to reflect the configuration of a water mist corner test and fire load for offices. The continuous wood crib had a fuel load of 570 MJ/m². Most of the window and door openings were closed off with some of the openings left open to replicate the condition in a naturally ventilated office building where some of the windows may be open to allow fresh air in. There was a slight breeze during the experiment. The fire was successfully controlled and mostly extinguished by the automatic suppression system, with only a small area of limited flaming extinguished through manual firefighting intervention. There was only limited discoloration visible at the CLT ceiling in the immediate vicinity where the fire was ignited (See figures 7, 8 and 9). This experiment showed the effectiveness of an automatic fire suppression system with large areas of exposed mass timber.

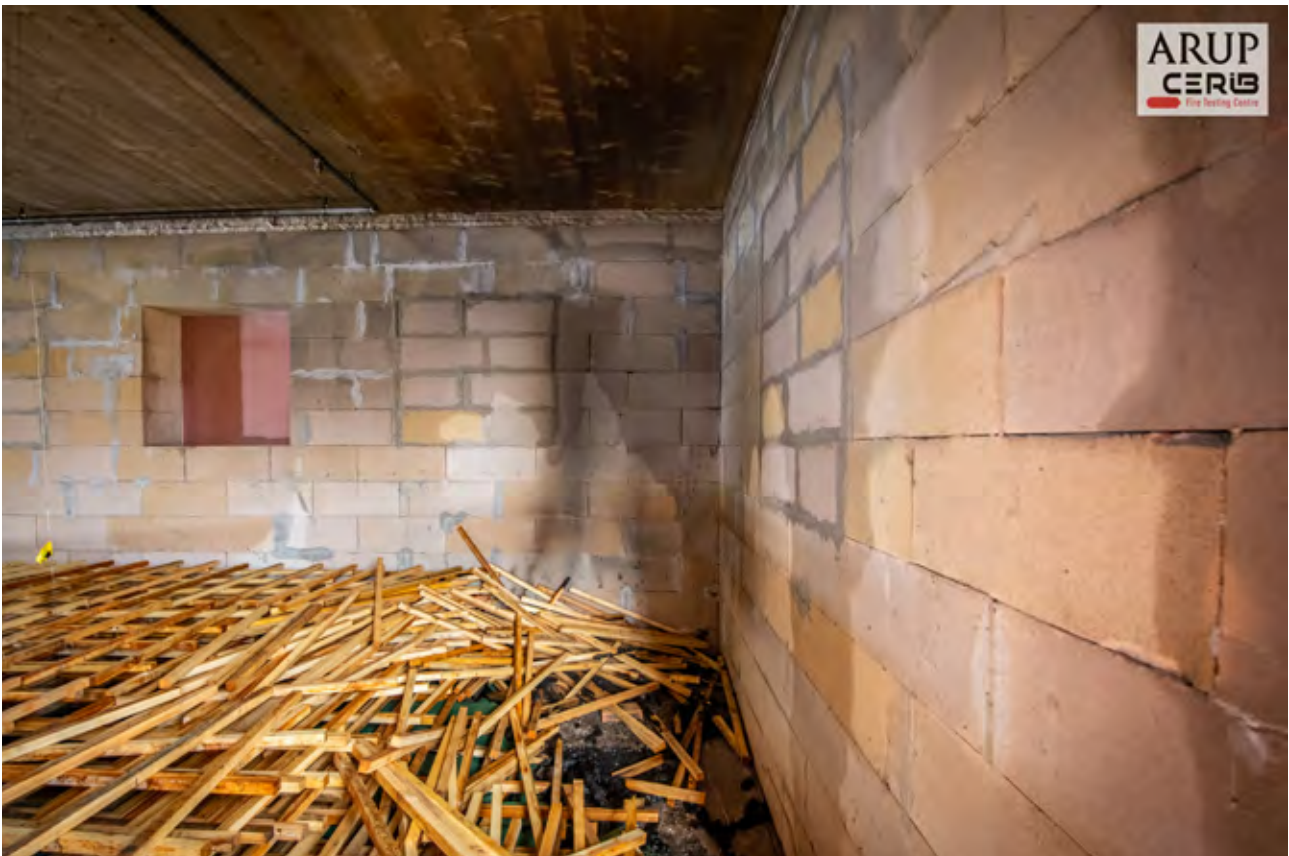
Figure 9. Limited damage to the wood crib and discolouration of the ceiling after the extinguishment of the fire.

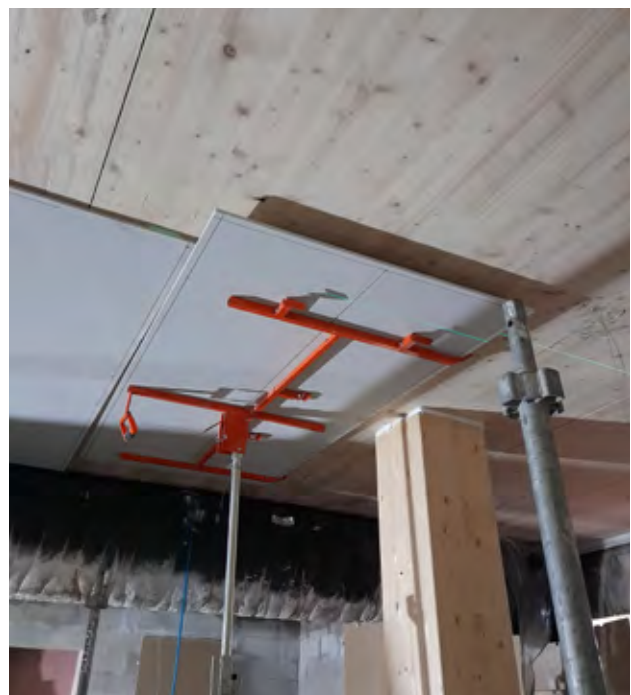
Figure 10. Installation of board protection to the CLT ceiling.

The fourth experiment was conducted on the 14th of December, 2021, and was identical to the first experiment, with regards to the structure, the fuel load, and ventilation. The CLT was protected by 3 x 12.5mm boarding achieving a K₂60 classification, covering just under 50% of the ceiling, to study the impact of part CLT protection on fire dynamics (See [figure 10](#)). The CLT protection was located centrally within the building and along nearly the full length, replicating the architectural intent to have timber exposed at the building perimeter near the windows. Both screws and staples were used to fix the board protection. In addition, eight 1m² sample of floor protection and over 60 ceiling mounted service fixings were included, to replicate supports for HVAC services commonly found in office buildings (e.g light, mechanical ductwork, data cabling, fire safety systems etc). Half of the fixings were fixed directly into the CLT and the other half into the protected CLT.

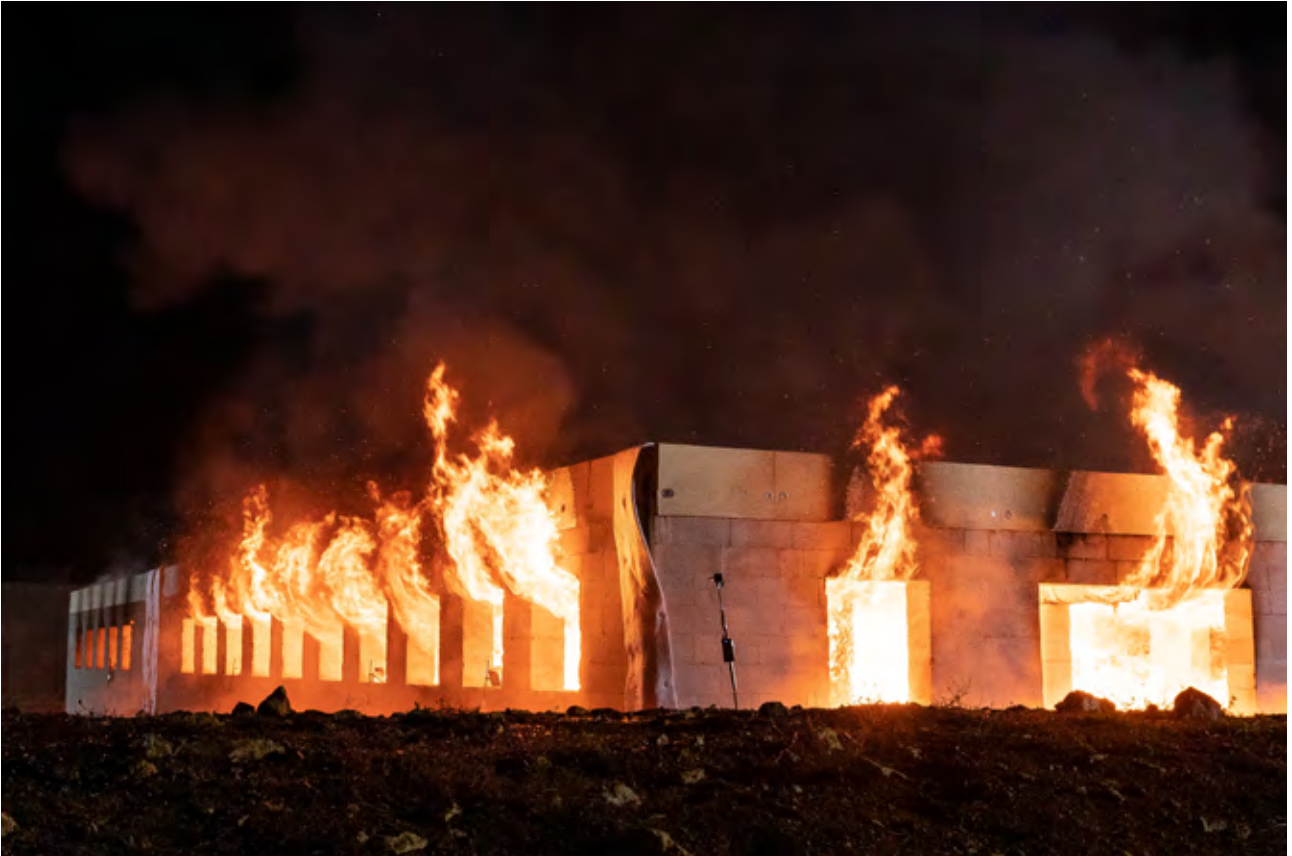
Figure 11. Photo from experiment four, showing extensive external flaming from openings at one end of the building, as the fire reaches the end of the compartment 34 minutes after ignition. Wooden crib at the ignition end of the compartment has largely burnt out already.

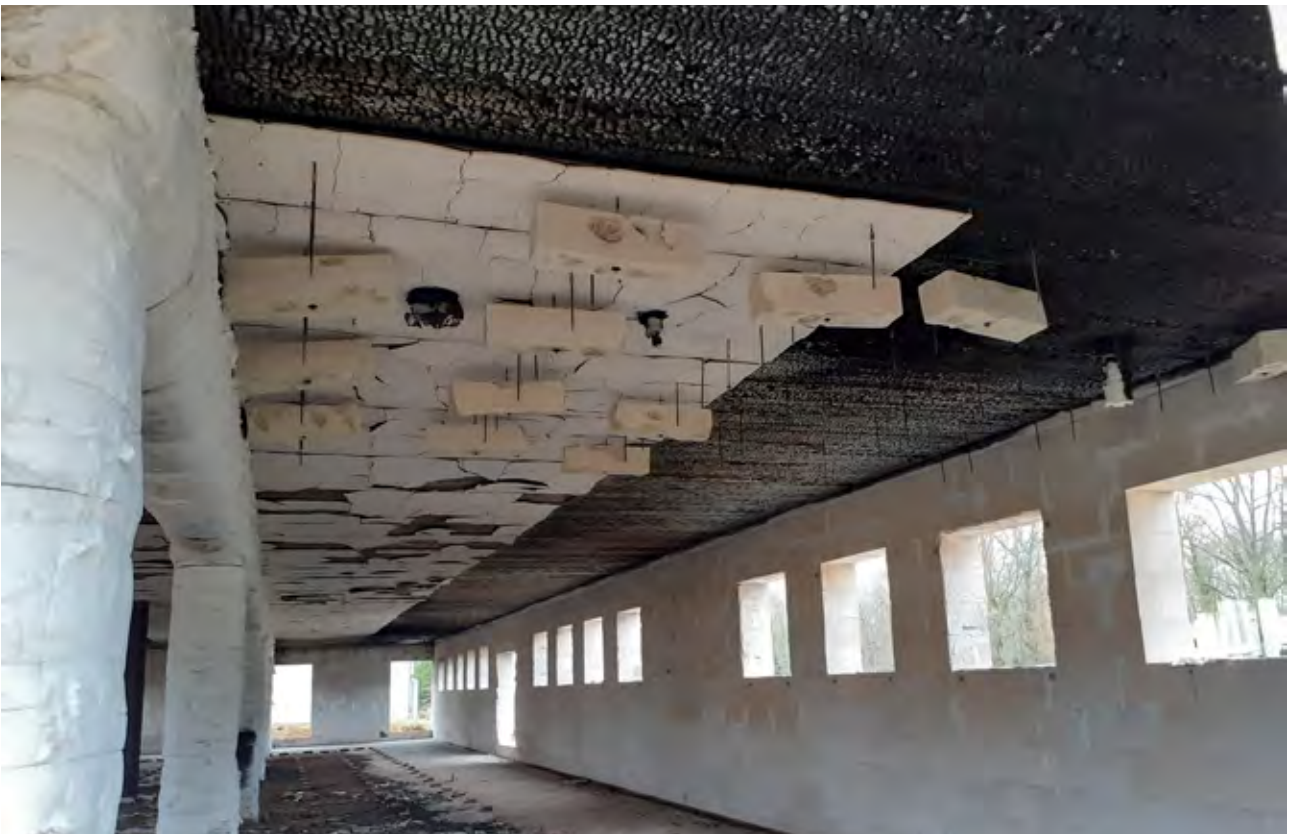
Figure 12. CLT protection the day after the fire, some localised failure of the outer layer visible, though CLT still protected by residual layers remaining intact; extensive failure of loaded services fixings visible with concrete blocks on the floor where loaded fixings were screwed directly into the CLT.

As occurred in the first two experiments, after a period of time the fire in the wood-crib reduced and flaming ceased at the CLT. Flaming was still visible at the columns for some time when there were only glowing embers remaining on the floor, though no ongoing smouldering at the base was observed in this experiment. Without firefighting intervention, small pockets of CLT again continued to smoulder for hours, again breaching the CLT thickness. Localised failure of the outermost layer of the CLT protection was evident during the cooling phase. Where the residual board protection remained intact, the CLT remained generally protected. Most of the loaded service fixings which were fixed directly to the CLT failed, while those fixed through the encapsulation remained in place. (See [figure 12](#))
