# THE ARUP JOURNAL

JUNE 1972

## Structural analysis and recording of ancient buildings

Poul Beckmann

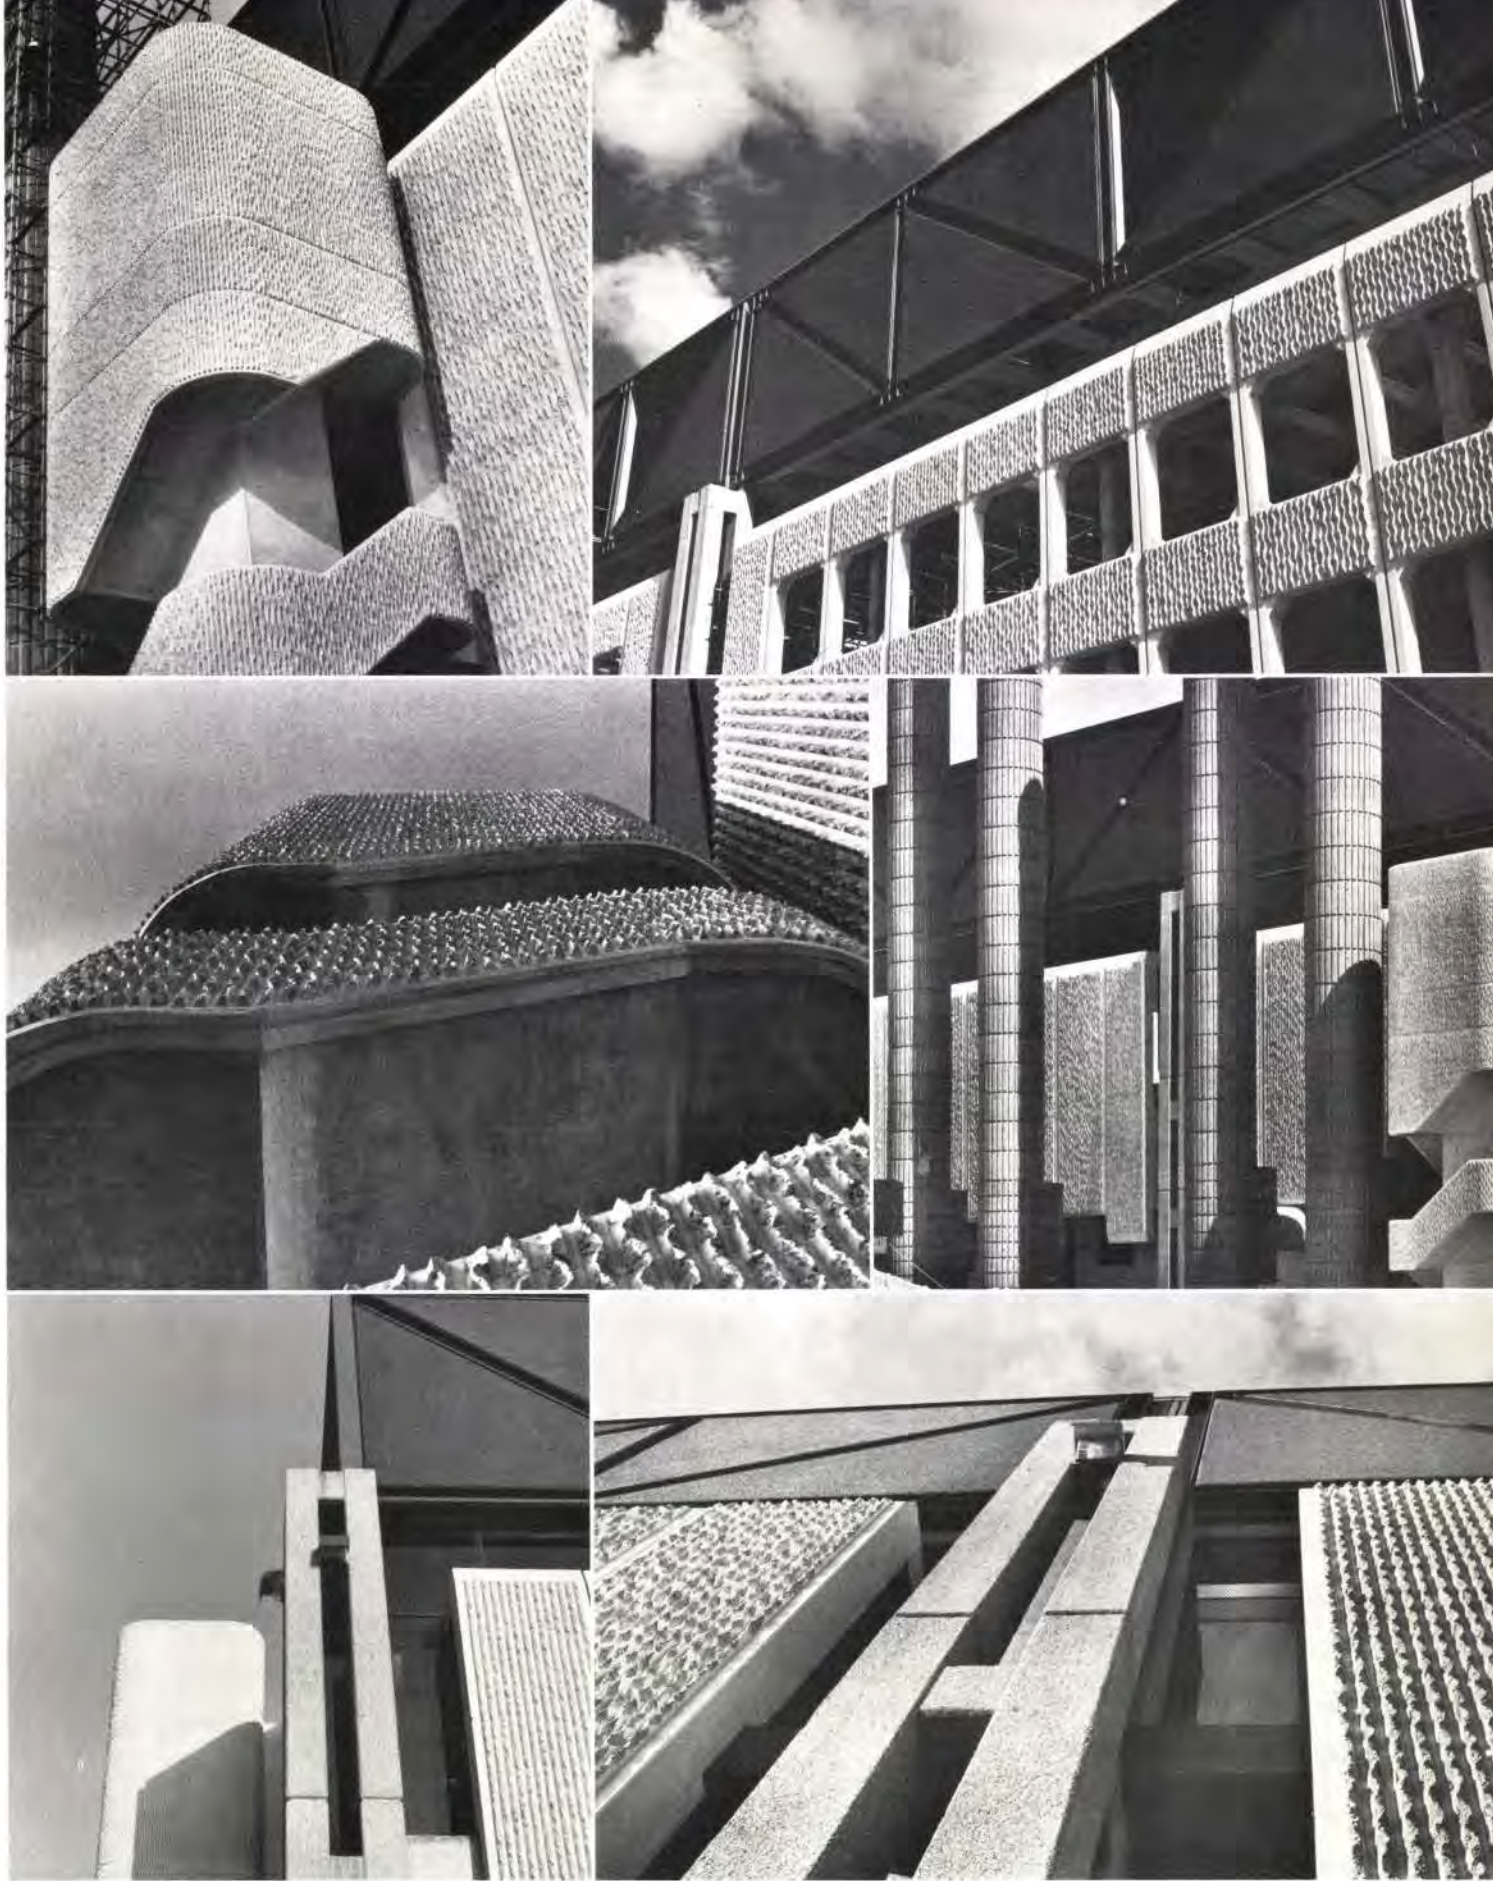
Textures and scale (the projecting ribs on the stairs are 40 mm x 35 mm, and on the cladding panels 85 mm x 80 mm)

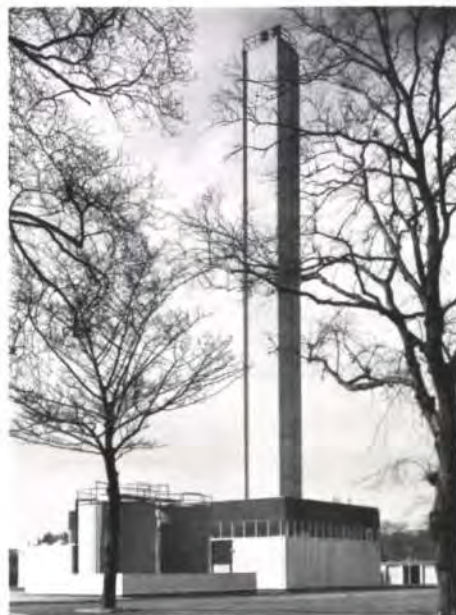
**Fig. 7 left**

Boiler and chimney (Photo: W. Ralston Ltd.)

The boiler plant is situated to the south of the ward block, and to avoid enveloping the wards in smoke, the chimney rises to a height of 64.5 m. It serves three boilers and there is space for three boiler flues, one incinerator flue and two future additions. (See Fig. 5).

The structural shell of the chimney is I-section in plan. Two walls and the spine are of structural concrete, and the other two are *Galbestos* cladding. The chimney is founded on a slab bearing directly onto rock.

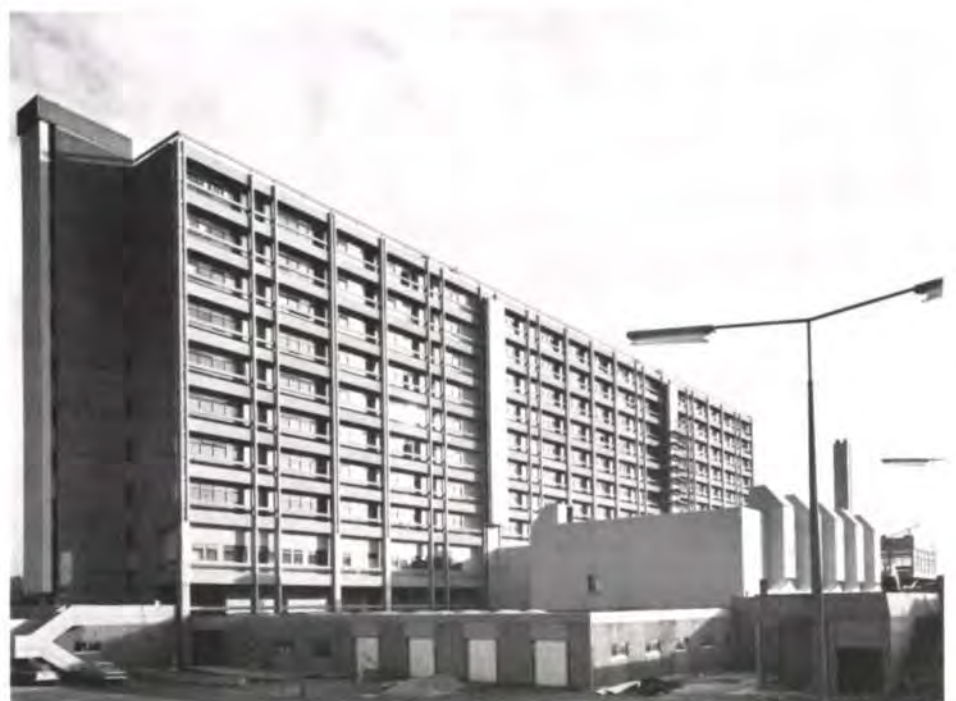
**Fig. 8 below**

West elevation of main hospital block  
(Photo: W. Ralston Ltd.)

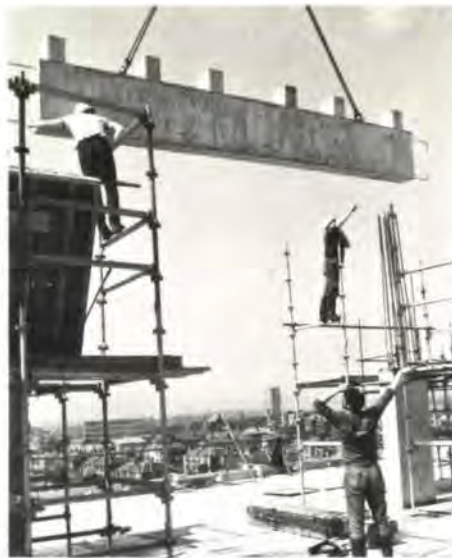
**Fig. 9**  
Erection of precast spine beam  
(Photo: Keppie Henderson & Partners)

Three lines of columns carry the floors. The outer two lines positioned outside the cladding, are of precast concrete, but the inner line, known as the spine columns, is in situ. They are at centres varying from 6.7m to 7.13m and carry a heavy precast spine beam in simply-supported sections running the full length of the building.

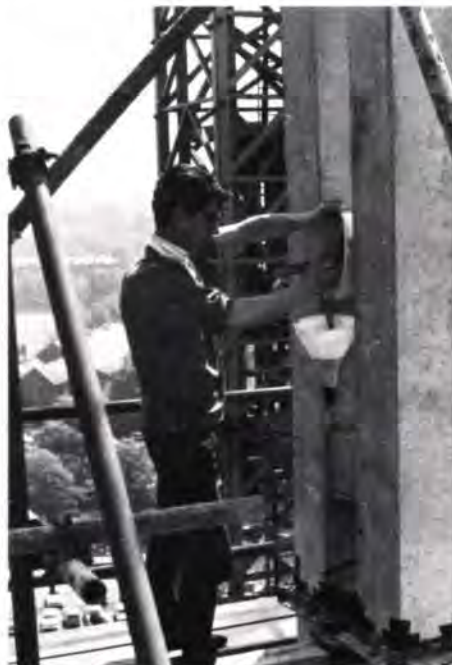
**Fig. 11**  
Operative pouring *Certite* column joint  
(Photo: Keppie Henderson & Partners)

The material finally chosen was pourable *Certite* grout in a mixture specially prepared for us by the manufacturers, SBD Construction Products Ltd., of Rickmansworth. This grout consists of a polyester resin, hardener and filler in the proportion of 1.15:1:1 by volume. The columns to be jointed were 250mm x 250mm in plan, in groups of two and four. (See Fig. 4). The material was poured from the top at A, and air was allowed to escape at B. When the grout appeared at B the hole was plugged and the reinforcing bar was finally grouted to the entrance at A.

Tests of mixing and pouring the *Certite* were carried out beforehand in a deep freeze with the object of studying joint construction under cold weather conditions. Cubes were cured at temperatures of  $-5^{\circ}\text{C}$  and strengths of  $105\text{ N/mm}^2$  at five days were obtained.
